Quality Standards for Temporary Traffic Control Devices

April 2024

616.19 Quality Standards for Temporary Traffic Control Devices

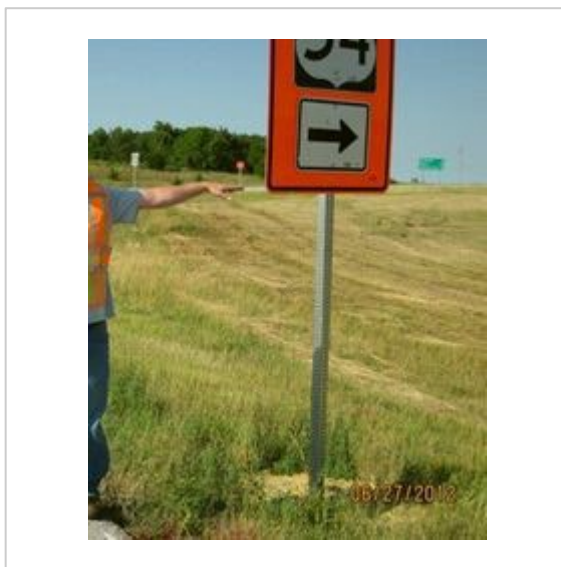
(1)

The post mounted sign shown in **Picture 1** is mounted 5-foot in height from the edge of the roadway to the bottom of the sign as required for a rural location. For urban locations, post mounted signs shall be 7-feet as shown in **Picture 2**. For short term projects temporary signs, as shown in **Picture 3**, may have a minimum height of one foot. For additional information on sign installation and heights see Standard (Std.) Plan 616.10.

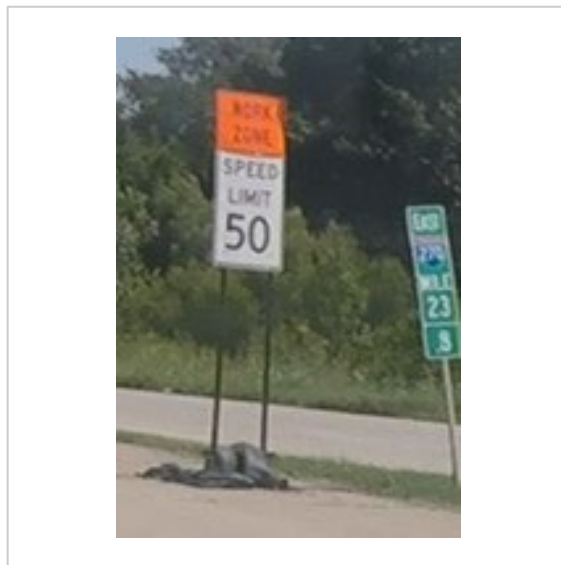
(4)

When used, speed limit (regulatory) signs shall be installed at a 5-foot (rural area) or a 7-foot (urban area) mounting height as shown in **Picture 4**. Information on the mounting height of the signs is in Std. Plan 616.10. The WORK ZONE PLAQUE (Go20-5Ap) shall be 2-foot height as shown in EPG 616.6.12 Work Zone and Higher Fines Signs and Plaques (MUTCD 6F12).

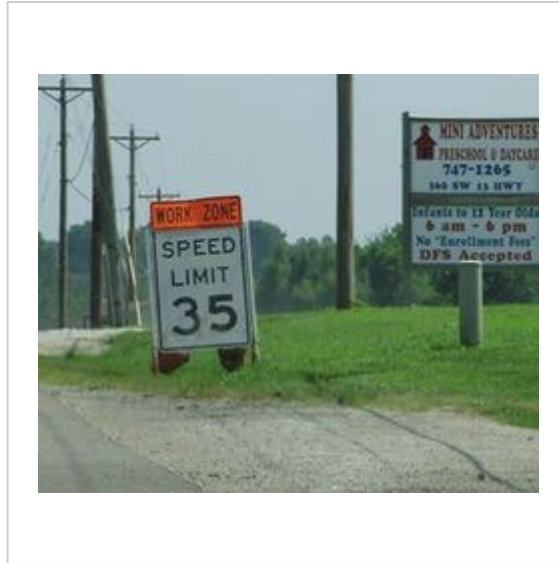
(5)

The mounting height and the WORK ZONE plaque (GO20-5aP) of the sign in **Pictures 5** is not compliant with MoDOT/MUTCD standards.

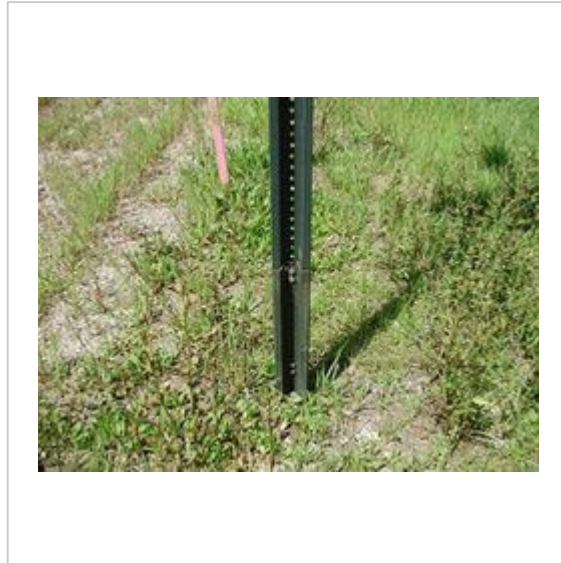
(7)

Picture 7 is an example of a correct U-channel post splice, which shows the four bolts in the proper location, correct stub height and splice overlap.

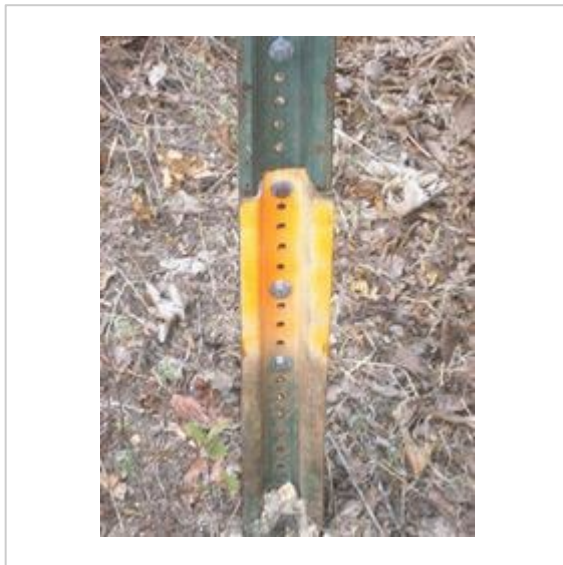
(8)

The stub height and splice overlap in **Picture 8** is correct, but the 4-bolts are not in the proper locations. **Picture 9** shows inadequate stub height and overlap and the signpost is not on the correct side of the stub.

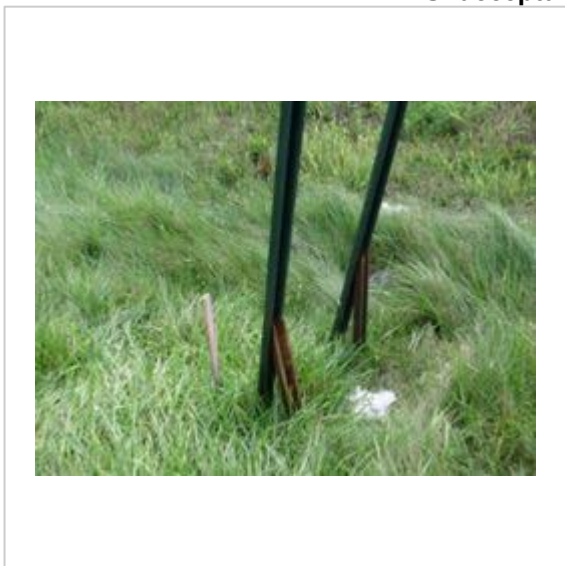
(10)

The installations in **Pictures 10-12** are unacceptable. **Picture 10** shows an installation of only 1 bolt per signpost leg. **Picture 11** shows an installation of one post mounted leg and one skid mounted leg. **Picture 12** shows two splices when only one splice is allowed.

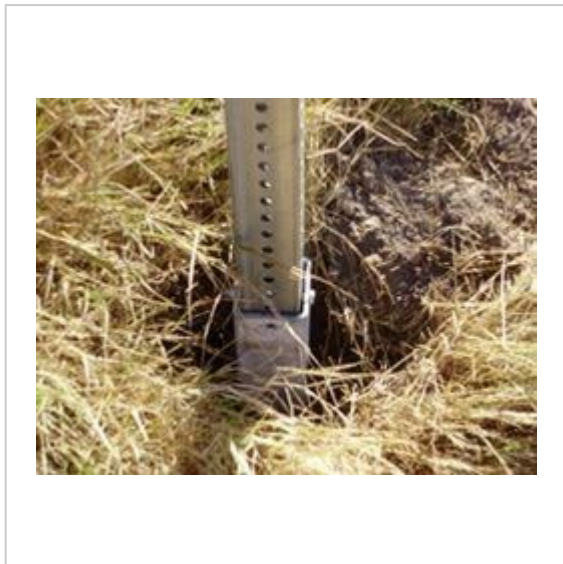
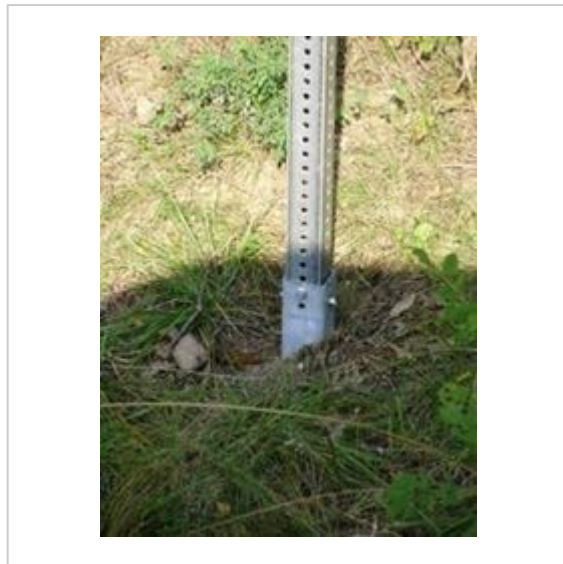
Pictures 14 and 15 show proper installation of a PSST post. The PSST post does not have to use the corner bolt but can be bolted either with one or two straight bolts. However, the corner bolt minimizes movement of the post within the tubes.

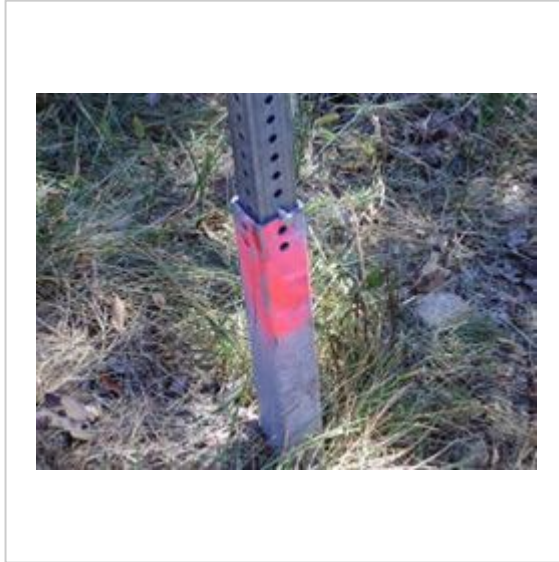
(16)

Picture 16 shows a stub higher than the 2-inches maximum and the bolt should be bolted through the two posts.

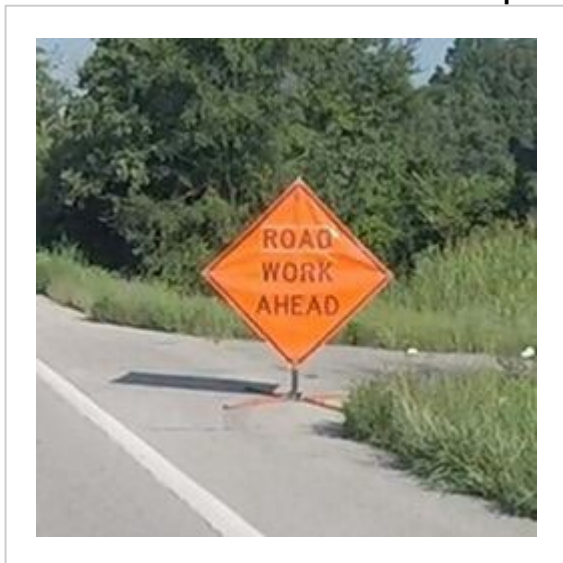
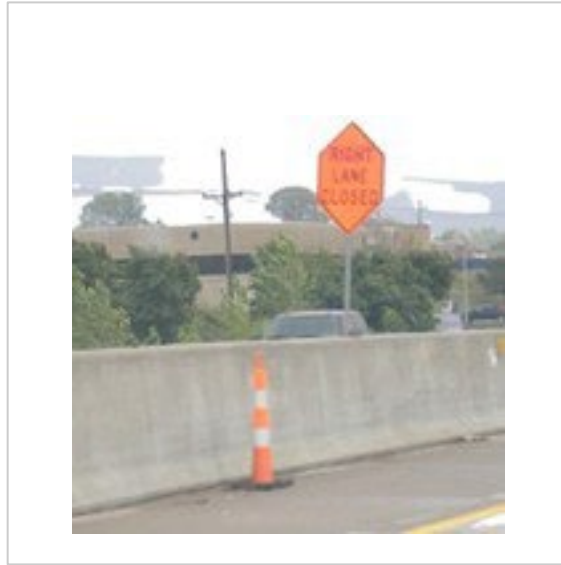
The signs in **Pictures 1, 2 and 3** are considered in good quality. Supplemental devices such as flags and/or a cone may be placed next to a sign. Picture 2 is an example of the proper placement of a FLAGGER (WO20-7) sign, with the optional flags, in advance of the hill versus after the hill. In urban areas with barrier walls and narrow shoulders, a truncated sign may be used as shown in Picture 3.

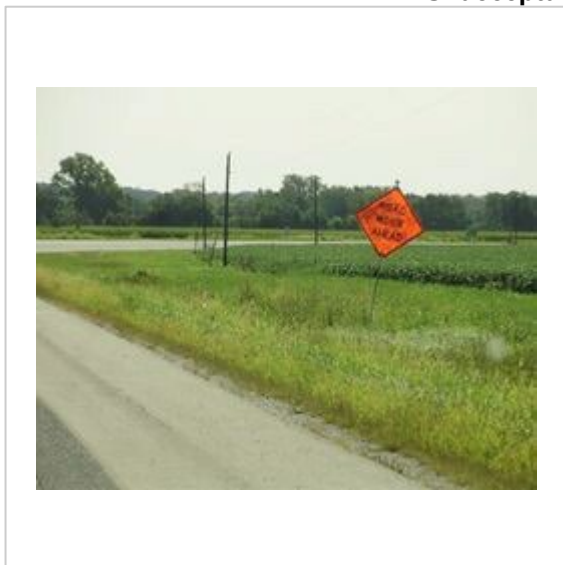
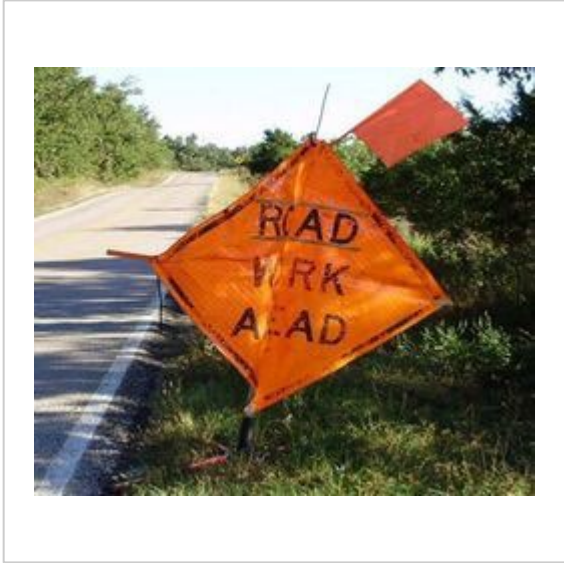
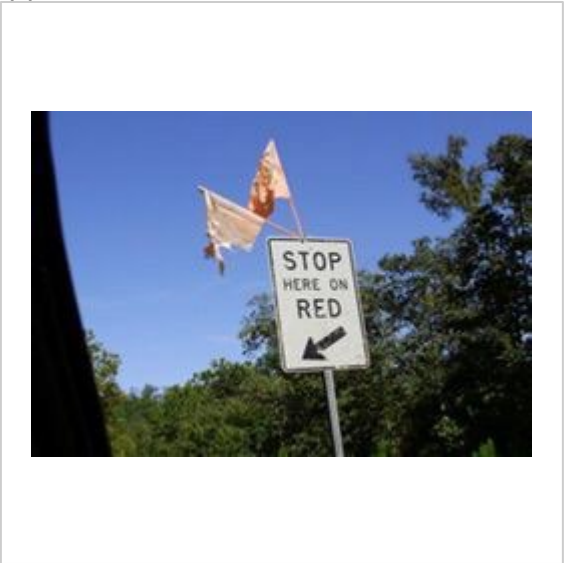
Pictures 4-7 are in unacceptable condition. Dirty or damaged signs should be cleaned, repaired, or replaced before being installed. When cleaning, follow manufacturer's recommendations, so the daytime and nighttime visibility of the sign is not adversely impacted. The MEN WORKING sign (**Picture 8**) should be replaced with worker symbol sign or WORKERS sign (WO-21-1 or 1a) to meet current standards. **Picture 9** shows unacceptable flags, if used, deteriorated flags should be replaced.

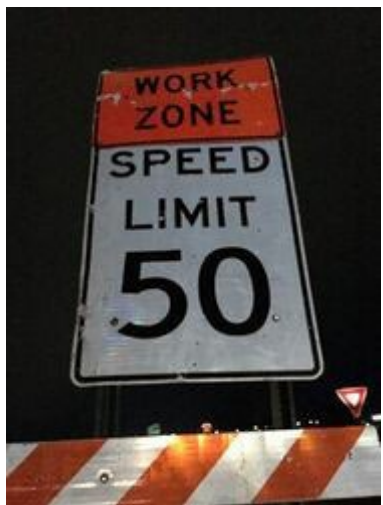
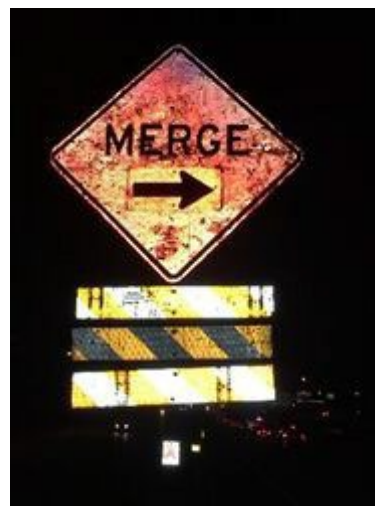
Pictures 10 - 13 are examples of unacceptable nighttime visibility. Proper storing, transporting, and covering signs is crucial to minimizing deficiencies.

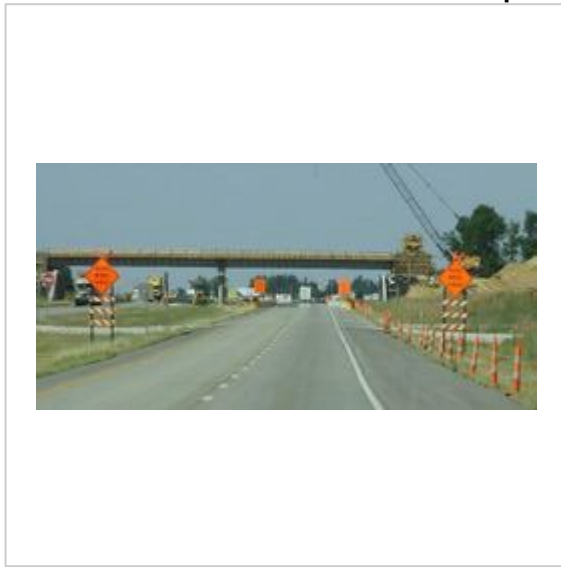
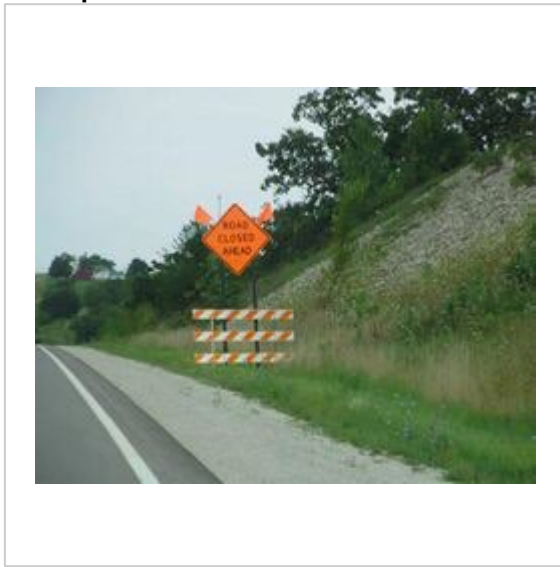
Advance Warning Rail System (AWRS) shall be installed on the first advance warning sign (Road/Bridge Work Ahead) on long-term stationary projects. The barricade stripes shall slope downward toward the roadway as shown above. **Picture 14** is an example of acceptable AWRS installations. When a Type 3 Barricade is used with a sign as shown **Picture 15**, the barricade shall be located between 7 to 10 feet from the sign (to be crashworthy). Either a 4-foot or 8-foot barricade may be used. A 4 foot AWRS on single post is acceptable as shown in **Picture 16** provided the signpost has been sized to accommodate the added weight and square footage of the AWRS.

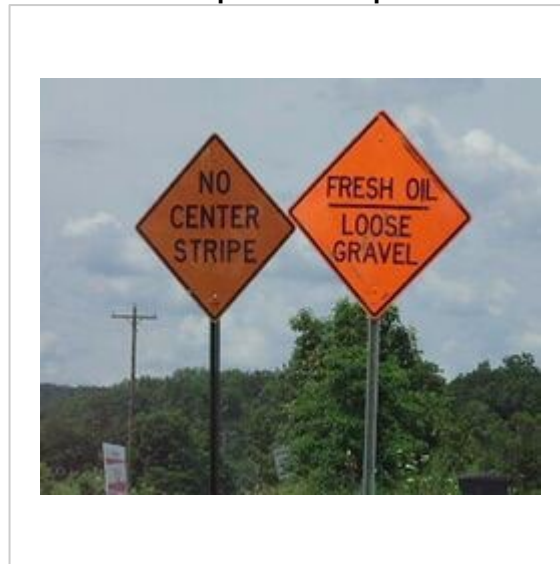
(1)

Fluorescent orange signs as shown on the right in **Picture 1** are required for MoDOT contract and maintenance projects. Permit projects may use engineering grade sheeting as shown on the left side of **Picture 1** provided they meet MUTCD reflectivity requirements.

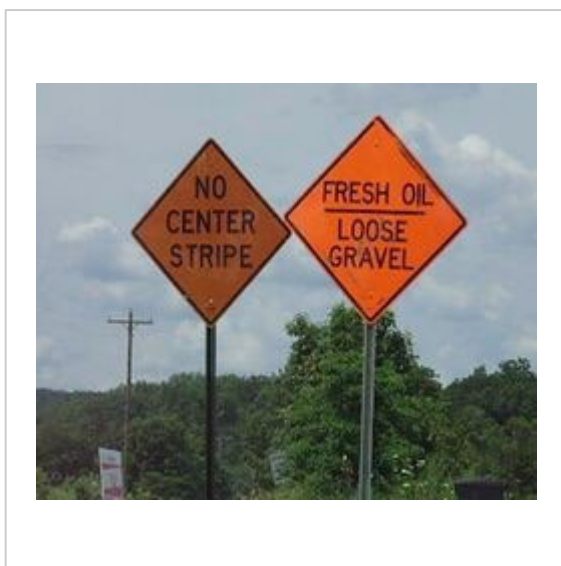
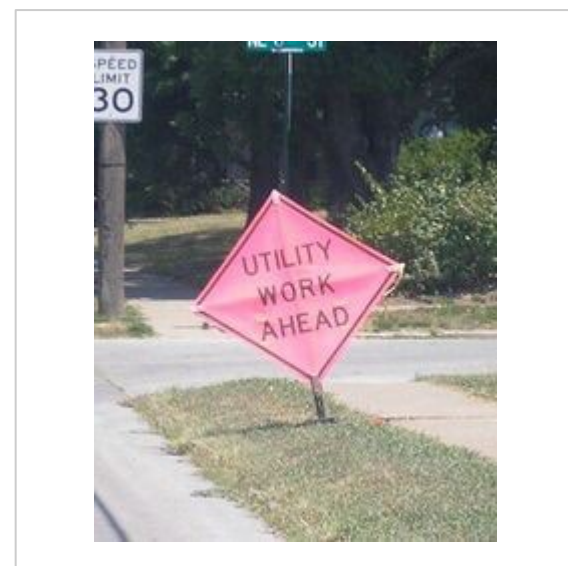
The UTILITY WORK AHEAD (WO21-7) and the LANE CLOSED AHEAD (WO20-5) signs in **Pictures 2 and 3** should be orange not pink or yellow. Note: Using tape on a sign can destroy the retroreflectivity of the sign as shown in **Picture 3**.

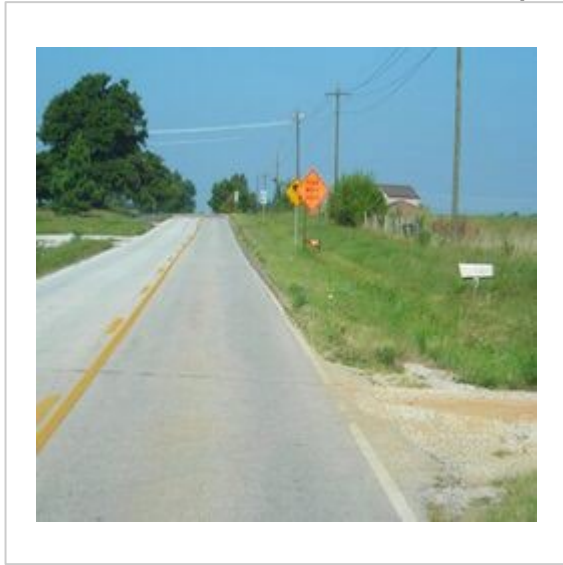
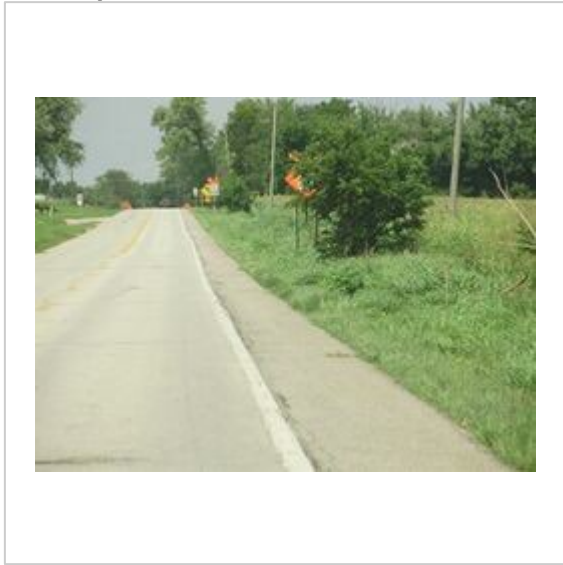
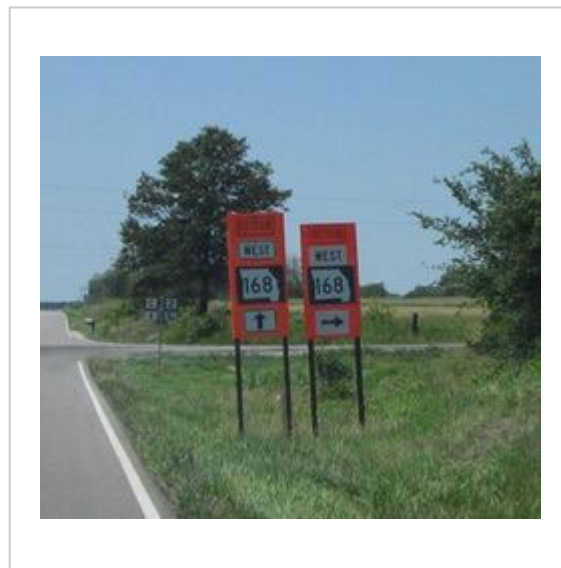
Pictures 1 - 3 are examples of signs that are visually obstructed or providing conflicting information. **Picture 1** should be moved upstream from the permanent curve warning sign with written documentation as to why the sign was moved. The advance warning sign in **Picture 2** should be relocated upstream of the tree or the tree should be trimmed (if within MoDOT ROW) to provide the required visibility. **Picture 3** shows detour signs that are providing two detour options for the same route. To reduce road user confusion, it is best to provide only one detour option.

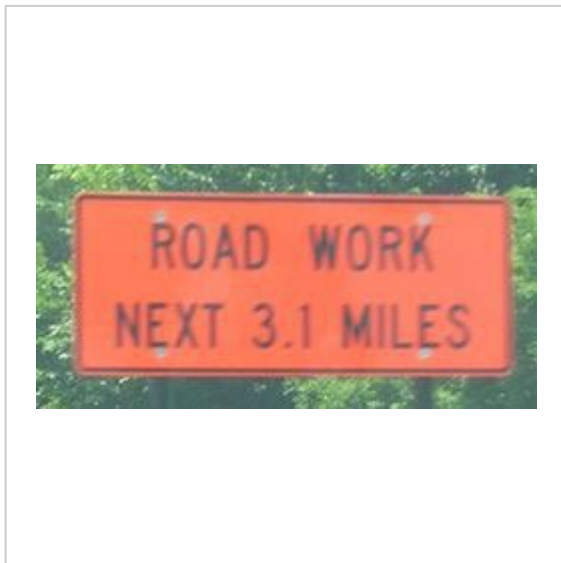
(5)

Pictures 5 and 6 are unacceptable signs because the specified miles are not listed as whole numbers.

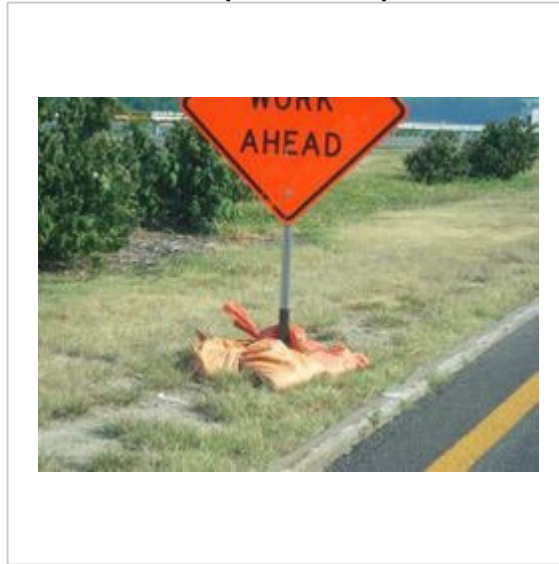
(1)

For portable signs, ballasting should be limited to one sandbag layer on the sign legs as shown in **Picture 1**.

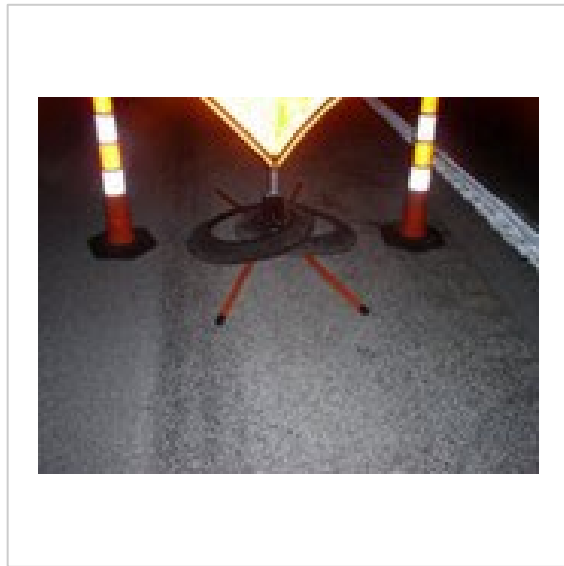
The use of channelizer rings as shown in **Pictures 2 and 3** are unacceptable as the crashworthiness has not been verified.

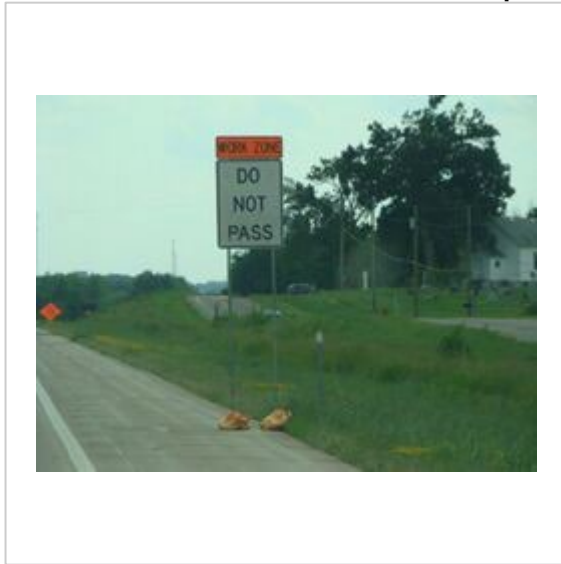
(4)

For skid mounted signs, ballasting should be limited to one sandbag layer on the sign legs as shown in **Pictures 4 and 5**. **Picture 5** shows an acceptable use of ballasting for a skid mounted sign. The crossbar (**Picture 5**) should be no higher than 12 inches (one sandbag over the crossbar is acceptable).

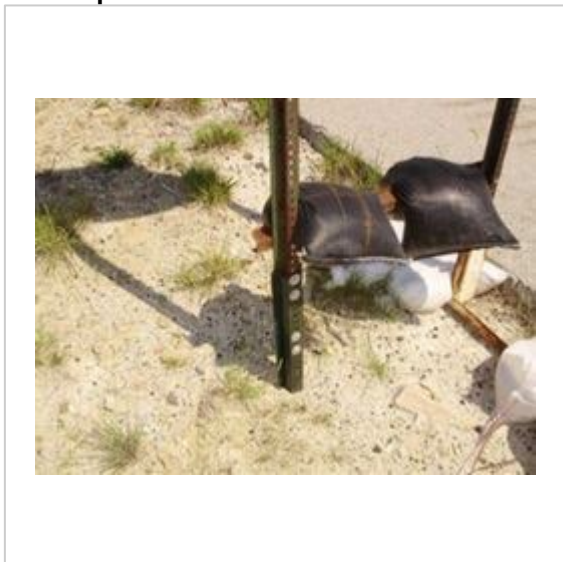
(7)

Picture 6 shows a large mound of sandbags, which if hit could present a ramping situation for vehicles. **Picture 7** has two sandbags on the crossbar which is unacceptable and utilizes two types of mounting styles. In **Picture 8**, concrete is being used to ballast the sign, which is not crashworthy and is unacceptable.

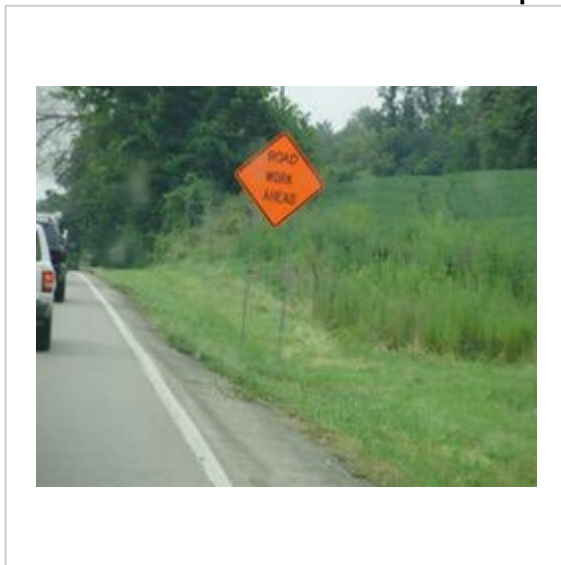
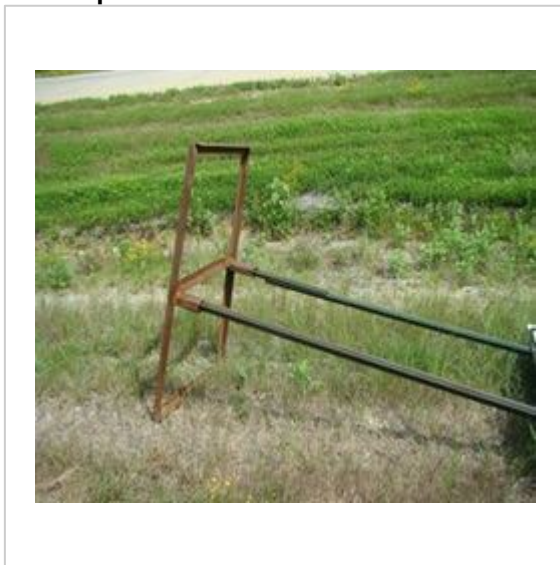
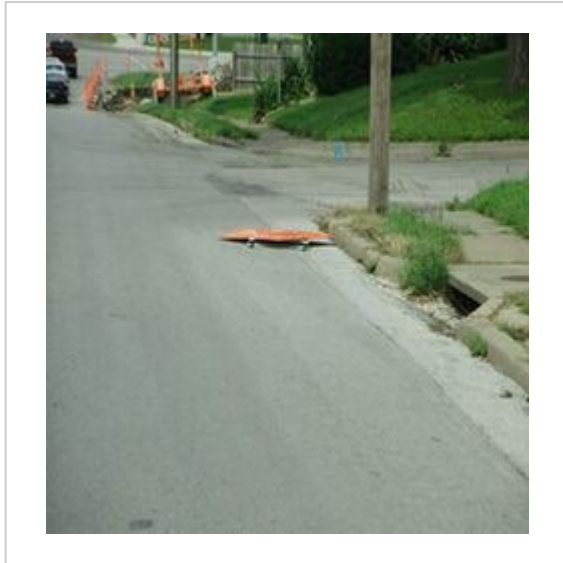
Picture 1 shows a crossbar above the 18-inch maximum height without sandbag or 12-inch maximum height with sandbag. **Picture 2** shows a skid mounted sign stand laying on the ground attached to the sign post. The skid mount should be removed from the sign post and placed flat on the ground. As shown, this sign stand is not crashworthy. **Picture 3** shows a sign laying in the street. This sign should be placed in a better location. **Picture 4** shows two crashworthy signs that have been placed closer than the recommended 7-10 feet spacing making them not crashworthy. The 7-10 feet spacing allows the signs to act independently of each other to meet crashworthy criteria.

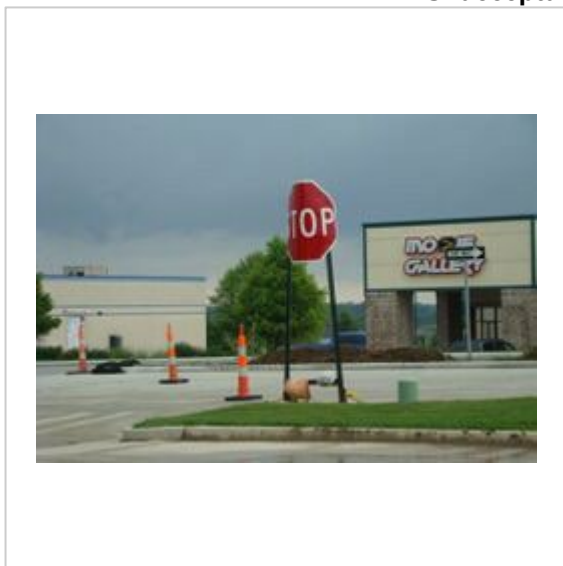
(5)

Picture 5 is an example of a STOP (R1-1) sign not having a full face visible to the road user. The sign in **Picture 6** is leaning and should be plumb. The sign in **Picture 7** could be moved upstream or downstream to achieve a plumb position. Be sure to document the location change, such as, “After reviewing the sign in the original position, the sign was moved 100-feet upstream to be achieve a plumb position”.

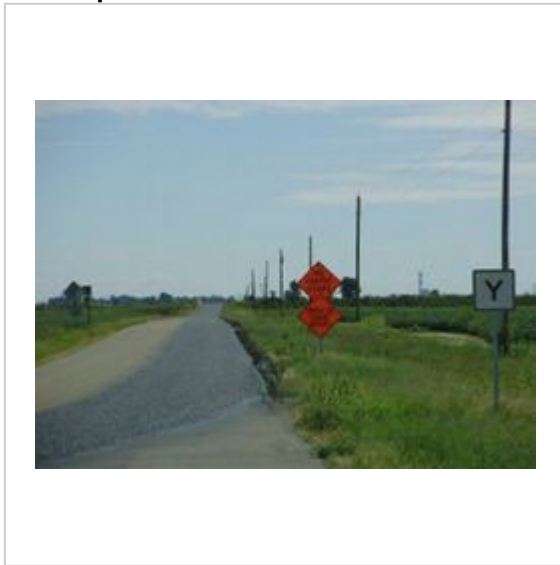
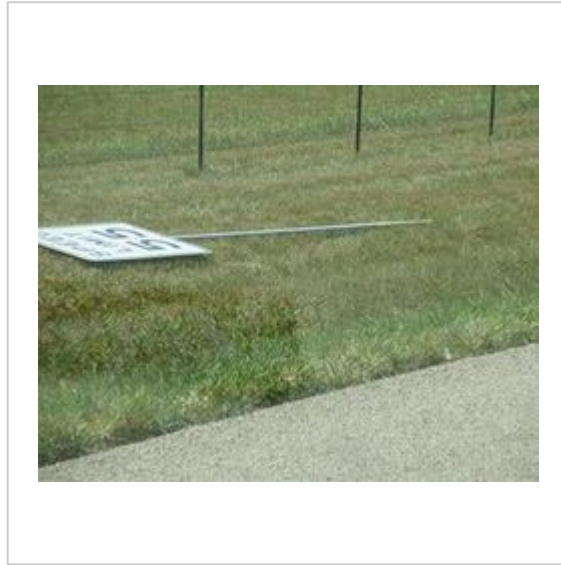
Sign placement in urban areas can impede non-motorized travel as shown in **Picture 8**. Accommodations should be made for all modes of travel including non-motorized traffic such as, pedestrians and bicyclists. The signpost in **Picture 9** should have only one sign. A permanently posted SPEED LIMIT (R2-1) sign, as shown in **Picture 10**, should not be removed. If the posted speed limit is lowered, the proper procedure is to cover the sign as described in [616.19.2.2.7 Sign Coverings](#).

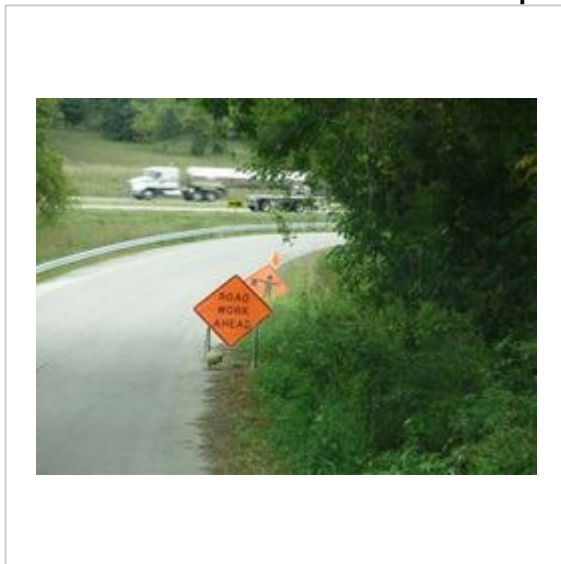
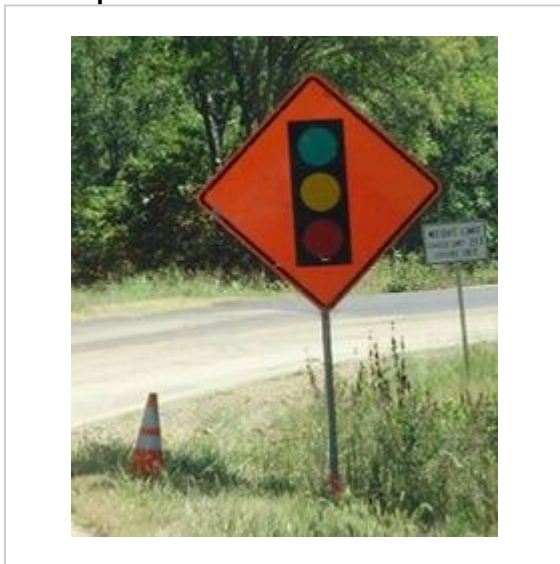
Picture 11 shows an example of two work zones placed inside each other. Proper coordination should be one of the highest considerations when work zones overlap each other. **Picture 12** shows the signal head upside down.

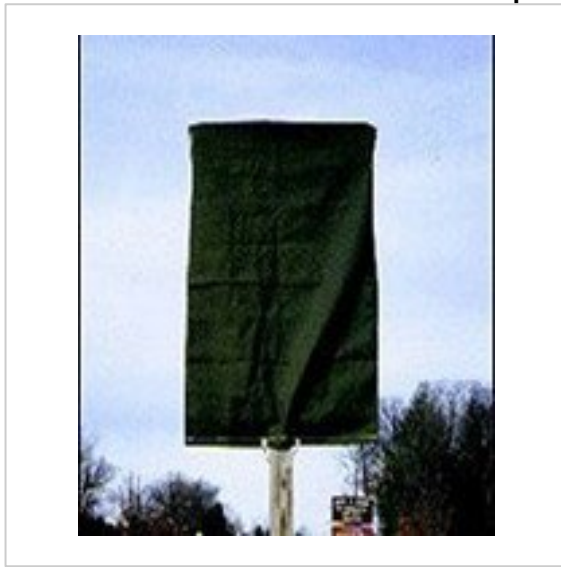
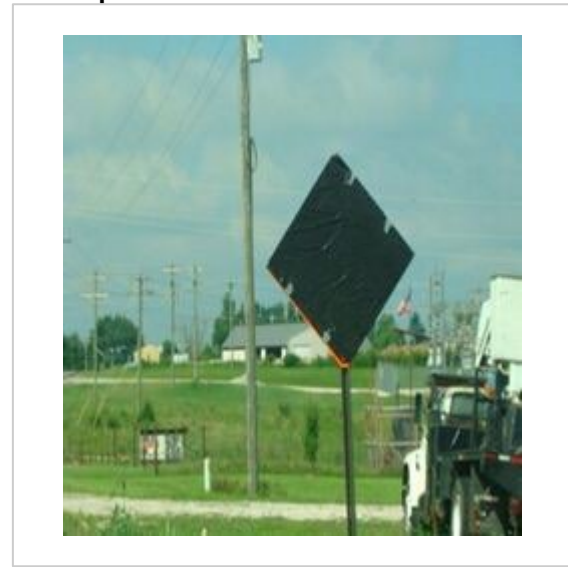
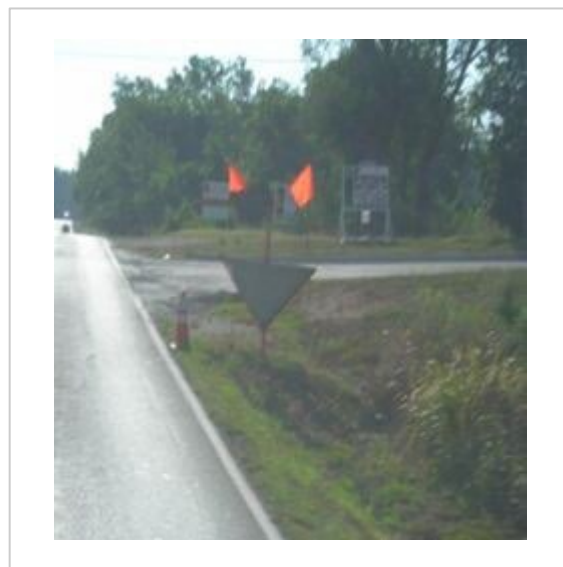
Pictures 1 - 3 show examples of signs properly covered with plastic sign cover, plastic taped securely to the sign without direct contact with the sign face and a roll-up sign folded down. Materials used should not allow the sign face to “bleed through” during daytime or nighttime use. **Pictures 1 and 2** adequately cover the face of the sign.

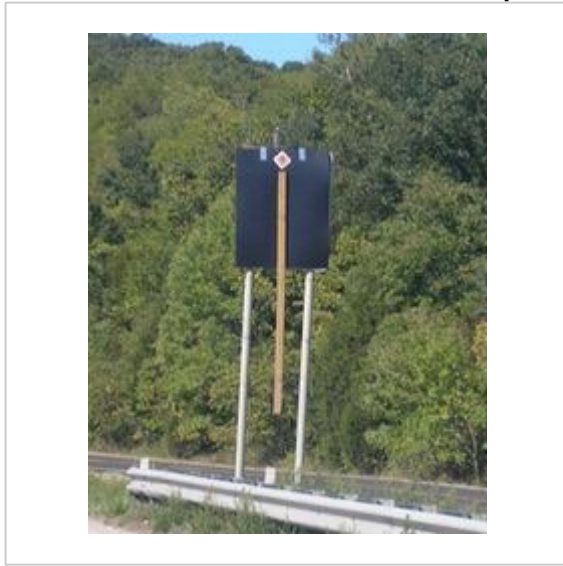
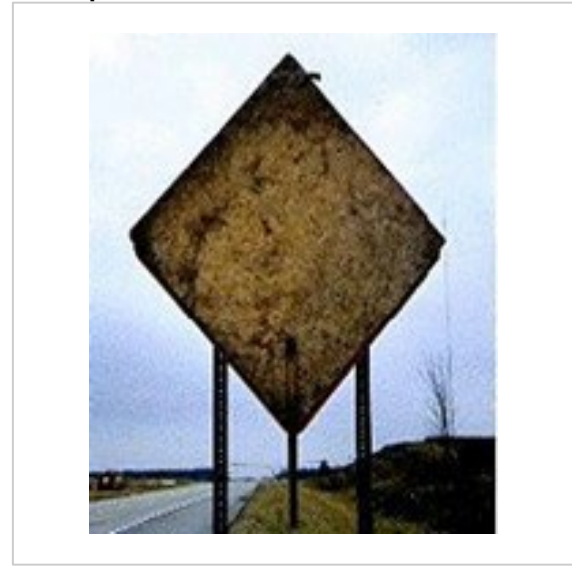
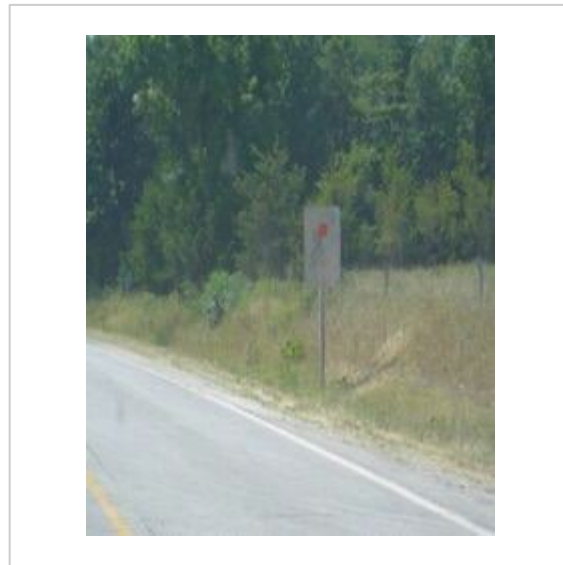
Pictures 4 - 6 are examples of acceptable materials to cover signs. Materials range from rubber that is used for mud flaps or a matching sized sign cover. The sign covers should be adequately secured to the host sign assembly and sized to match the sign to completely cover the face. The cover should be constructed with non-metallic (such as wooden, plastic, etc.) handles and spacers to keep the sign covers from damaging the sign face.

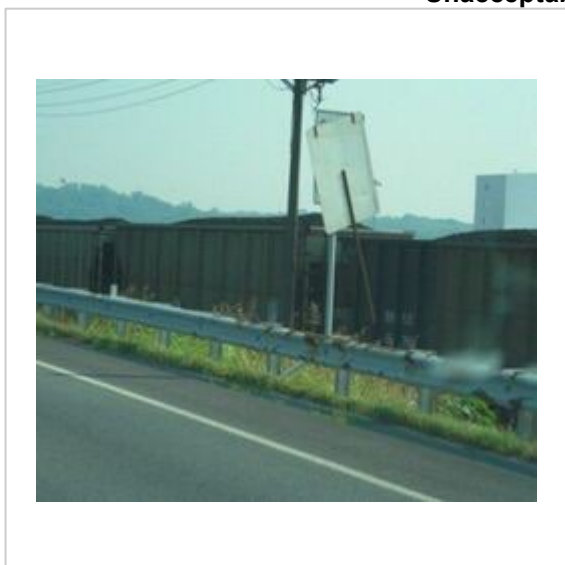
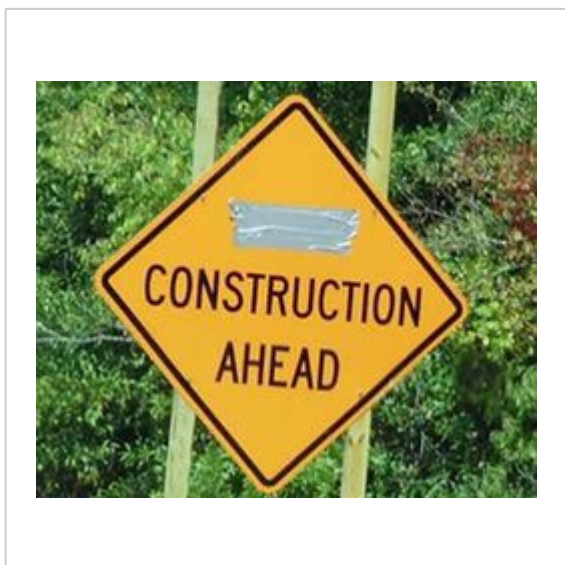
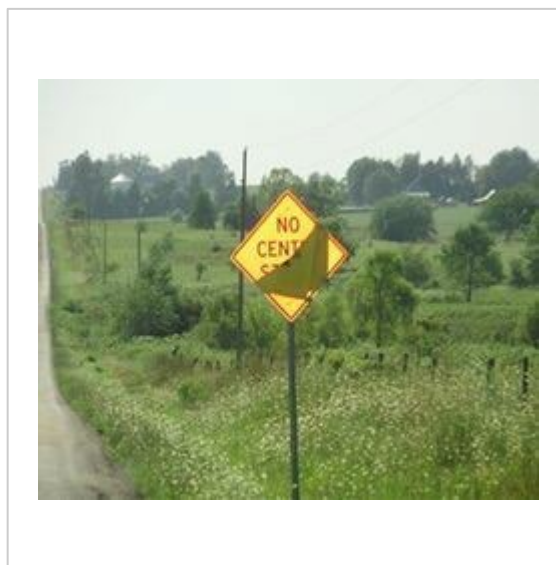
The sign cover in **Picture 7** is not securely fastened and does not have a non-metallic handle. **Picture 8** shows the sign cover not matching the shape of the host sign, which could provide conflicting information to the road user. **Picture 9** shows duct tape covering part of the sign wording, which can damage the sign retroreflectivity. **Picture 10** shows an example of unacceptable use of plastic taped to the sign. The plastic is thin which illustrates the “bleed through” of the message and it is falling off and the sign.

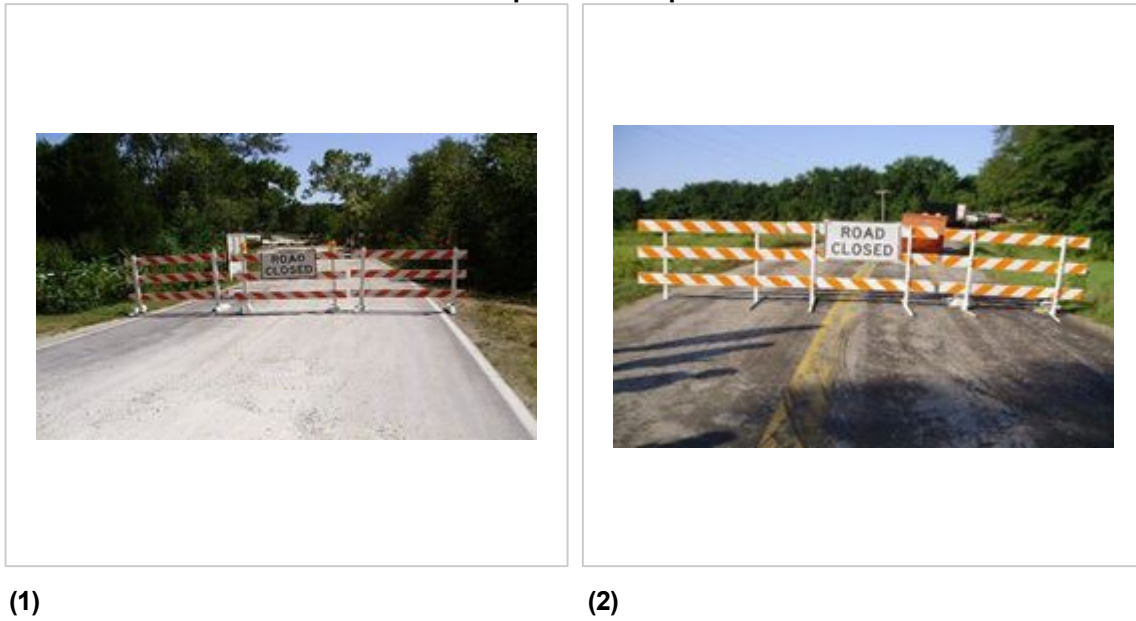
Picture 1 shows the proper placement of Type 3 barricades on a full roadway closure, including stripe direction. The barricade installation also provides an adequate buffer space to the work area. At some locations, barricades may have to be located at the bridge ends or work area due to side roads. **Picture 2** shows equipment behind the barricades.

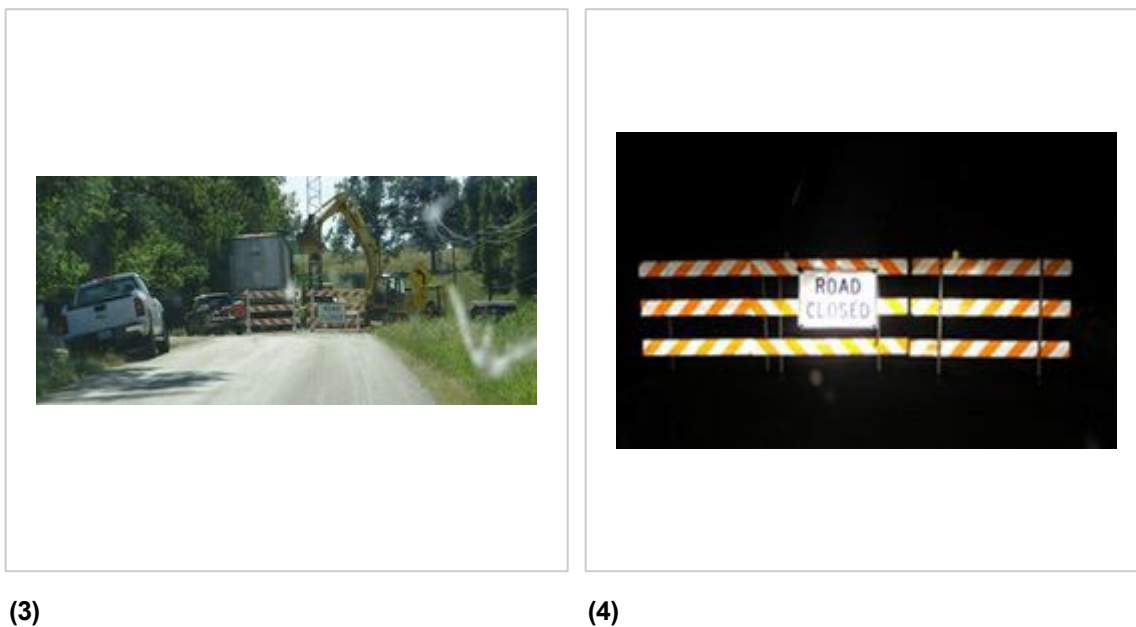
Picture 3 shows a barricade installation located after the private entrance and before the bridge end, not leaving enough buffer space. In **Picture 4**, notice the left barricade stripes are angling to the left instead of to the right.

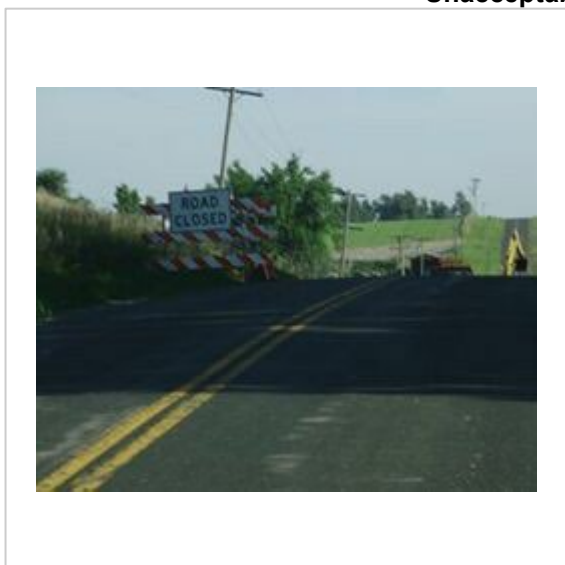
(5)

Picture 5 shows Type 3 barricades that were moved to let vehicles into the work zone. **Picture 6** shows a haul truck entering a work zone and leaving the barricades open which could allow the road user to follow the haul truck. **Picture 7** shows the barricades staggered to allow haul trucks in and out of the work zone which is not permitted.

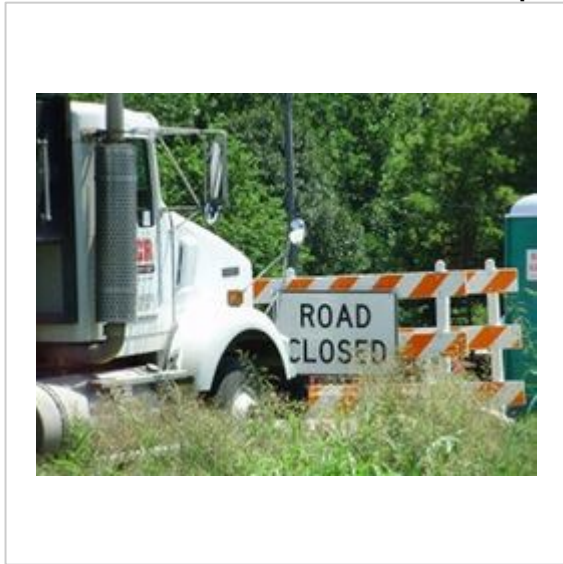
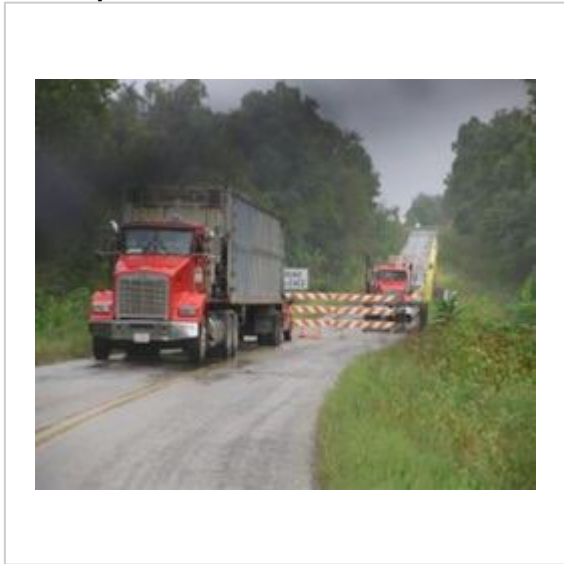
Pictures 8 and 9 show trucks parked in front of barricades, obstructing them from oncoming traffic. Note: Equipment or vehicles should not be parked in front of barricades they should be moved to an appropriate location (i.e., behind the barricades).

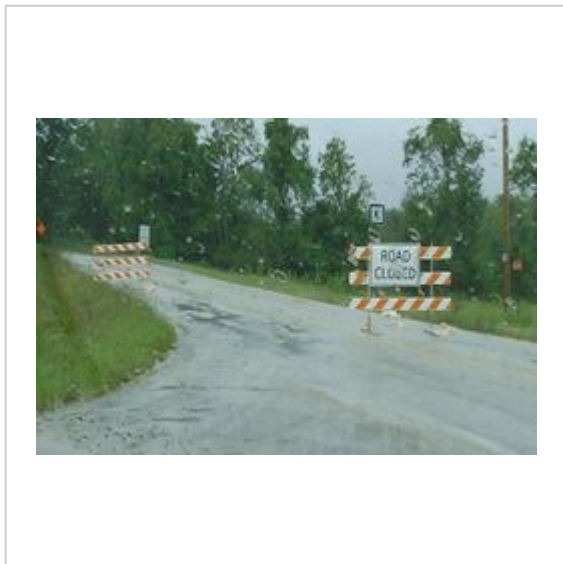
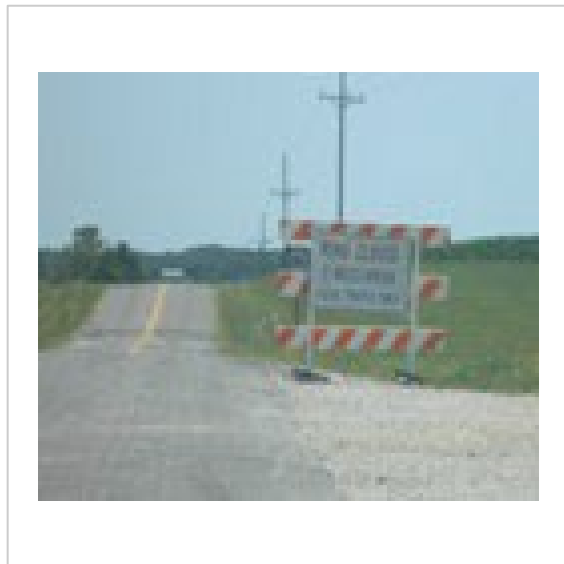
Picture 10 shows a soft closure which is intended to allow local traffic only to get to the desired destination before the full closure. One barricade and ROAD CLOSED (R11-2) sign as shown in **Picture 11** can be used to inform the road user of closures, which when used should be located on the shoulder.

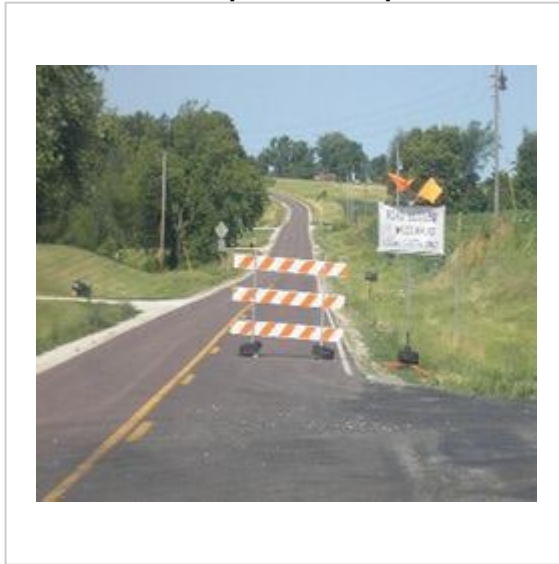
(12)

The barricade in **Picture 12** is directing the road user into the opposite lane and not directing them back into the proper lane of travel with another barricade in the opposite lane. A single “ROAD CLOSED XX MILES AHEAD” (R11-3a) sign is allowed without barricades. Note: A full barricade closure is required at the work area.

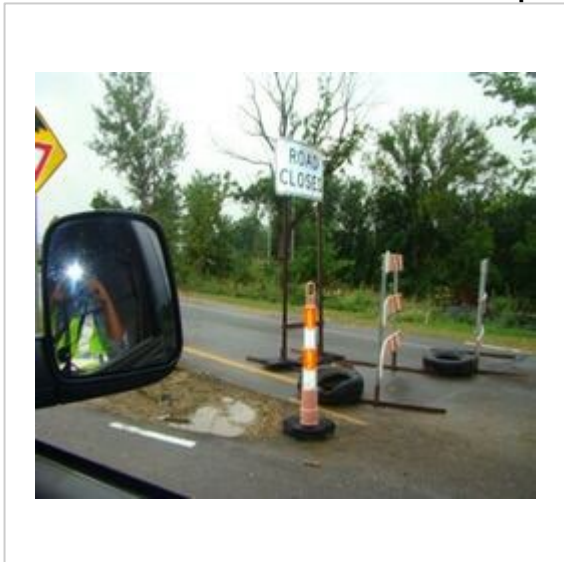
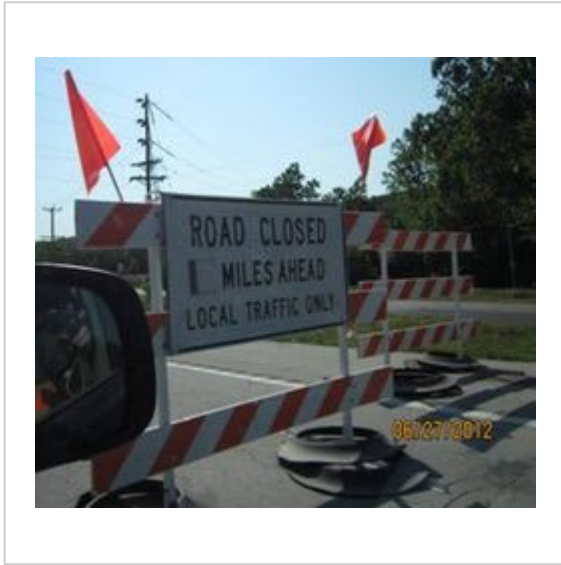
The ballasting in **Pictures 13 - 16** show unacceptable applications. Tires should not be used as ballast. Sandbags are allowed if they are not stacked on each other (i.e., a single layer to meet crashworthiness). As shown in Pictures **13 - 15**, the signs may be placed behind the Type 3 barricades. To be crashworthy, the sign and barricade should be separated by 7 to 10 feet from each other so each device can act independently if struck by a vehicle. **Picture 16** shows old barrel rings around the legs of the barricades. If rings are used, only one is allowed per leg.

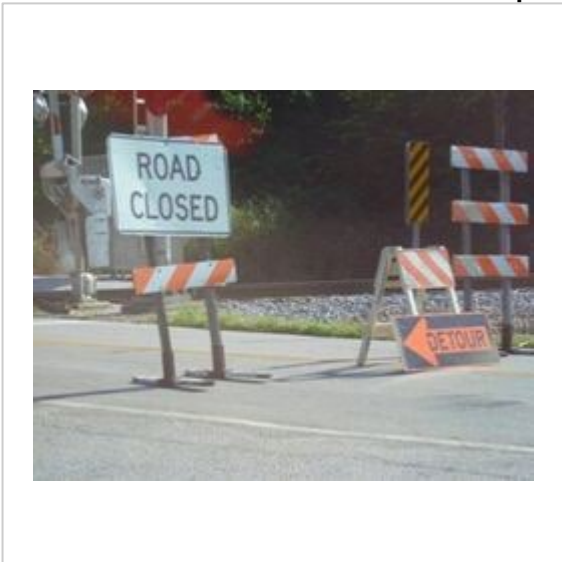
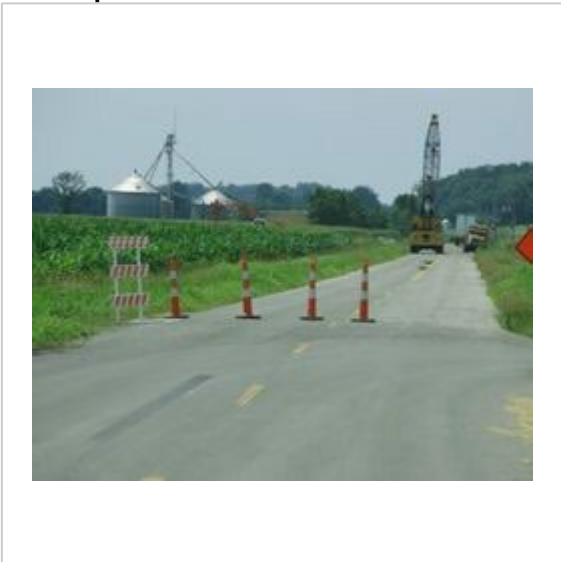
The road closures in **Pictures 17 -19** are unacceptable installations, the Type 3 barricades should cover the full roadway width to meet the requirements for a full road closure. The damaged rail sheeting on the barricades in **Picture 19** is unacceptable.

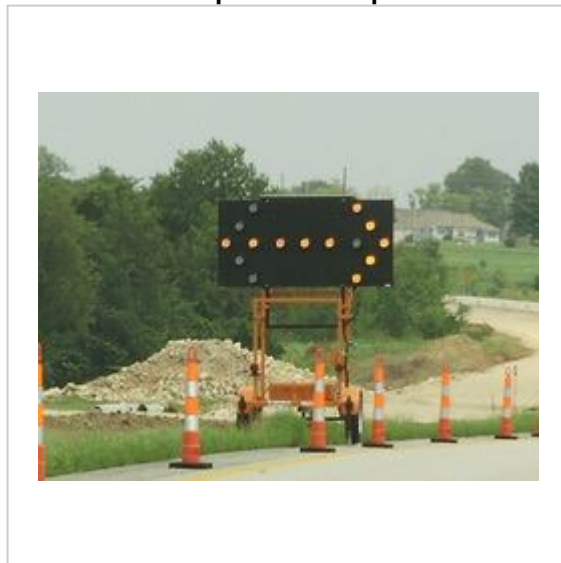
(1)

Picture 1 shows the correct flashing arrow panel (FAP) display, all lights are working and have the proper intensity.

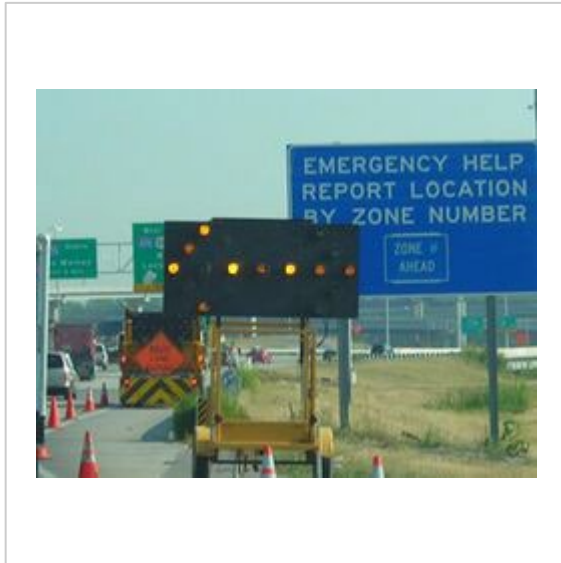
(2)

Picture 2 shows one lamp out in the arrowhead which is unacceptable. **Picture 3** shows a truck blocking a FAP which is unacceptable.
