Quality Standards for Temporary Traffic Control Devices

April 2024

616.19 Quality Standards for Temporary Traffic Control Devices

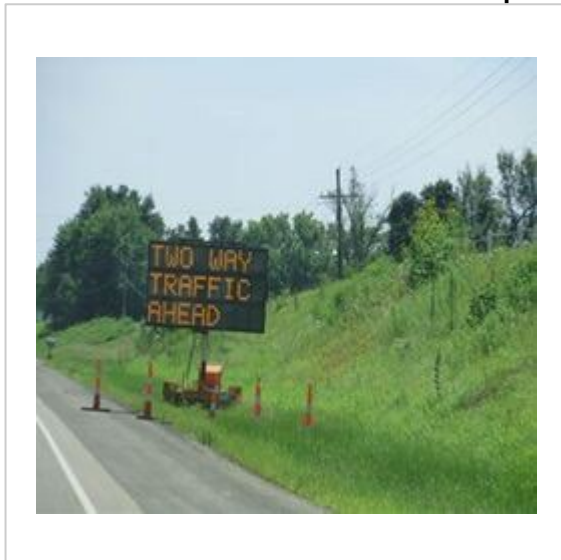
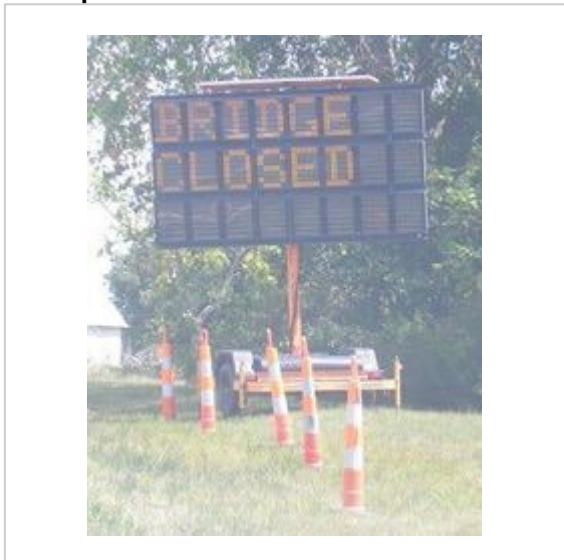
The Changeable Message Sign (CMS) messages in **Pictures 4, 5 and 6** are acceptable. The messages provide information that static signs cannot provide to the road user. The CMS are placed further upstream of the work zone or at strategic locations to provide information about the upcoming work zone to the road user. The channelizer placement in **Picture 4, 5 and 6** shows the correct number of channelizers (5) and the correct placement (100 foot taper). Channelizers are not required if the CMS is more than 15-feet from the edge of shoulder (edge of the roadway if there is no shoulder), beyond ditch line, or behind curb or temporary traffic barrier (TTB) (see Std. Plan 616.10 for further details). **Picture 7** shows a Dynamic Message Sign (DMS) providing information of a work zone. Appropriate messages can be found in EPG 910.3.2.10 Acceptable Abbreviations.

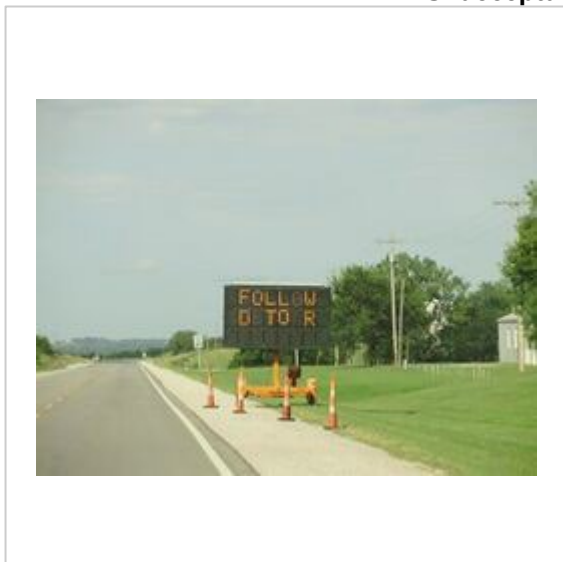
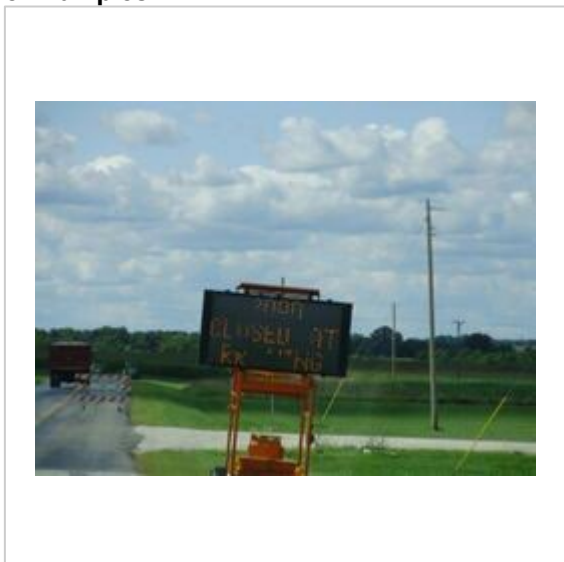
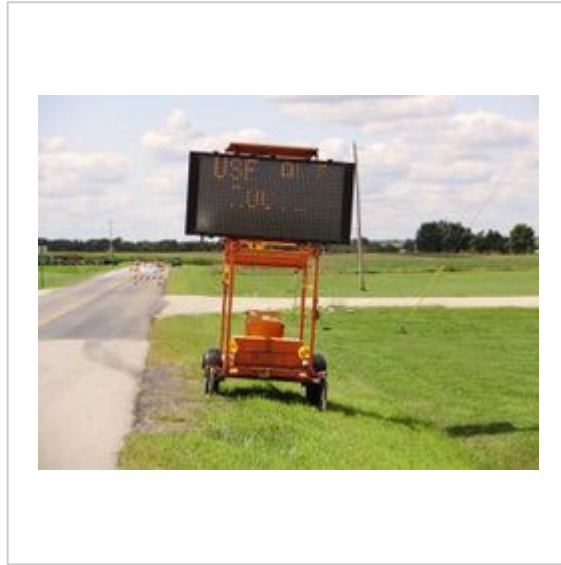
Pictures 8, 9 and 10 are examples of CMS that are unacceptable due to the lights being either the incorrect intensity or out, as they are not providing a clear and concise message to the road user.

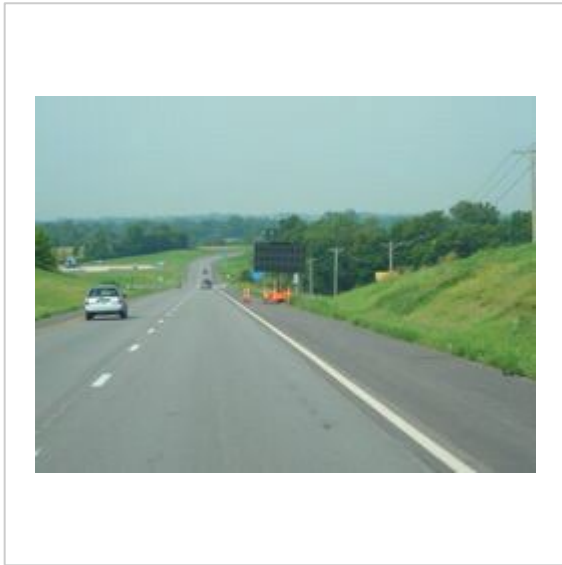
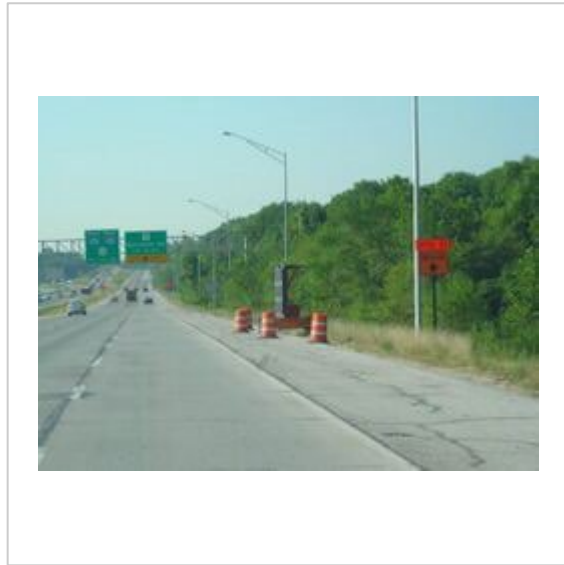
Picture 13 shows a CMS where the lights are out or turned off. If the lights are not working, the CMS is unacceptable. If the CMS is not being used it should be turned off and rotated away from traffic as shown in **Picture 14** or removed from the project. Note: The taper length should be 100 feet long with five channelizers.

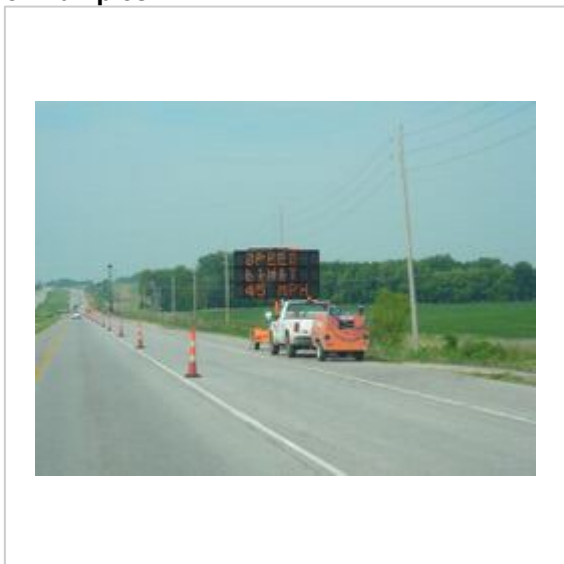
(16)

Picture 15 shows a permanent sign blocking the CMS. In **Picture 16**, the truck should not be placed in front of the CMS board. For **Picture 16**, the speed limit should not be on a CM.

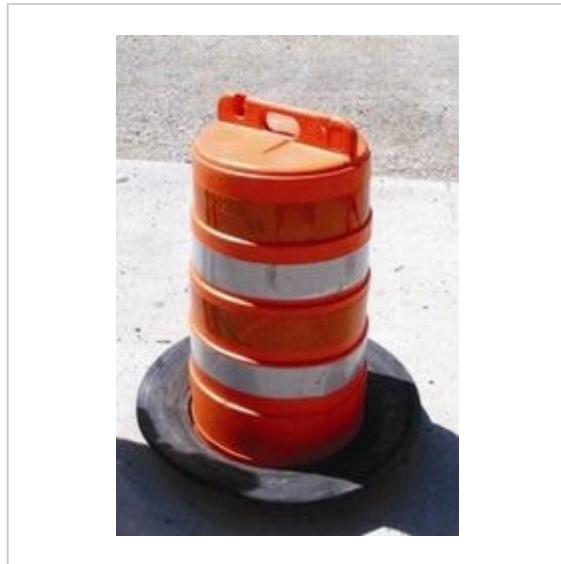
(4)

Trim-line shown in **Pictures 1 and 2** are the most commonly used work zone channelizer. **Picture 3** shows trim-like channelizers with sequential lights on a nighttime interstate project. **Picture 4** shows a drum-like channelizer. Trim-line and drum-like channelizers are commonly ballasted with weights called “rings”, which prevent the channelizers from being blown over.

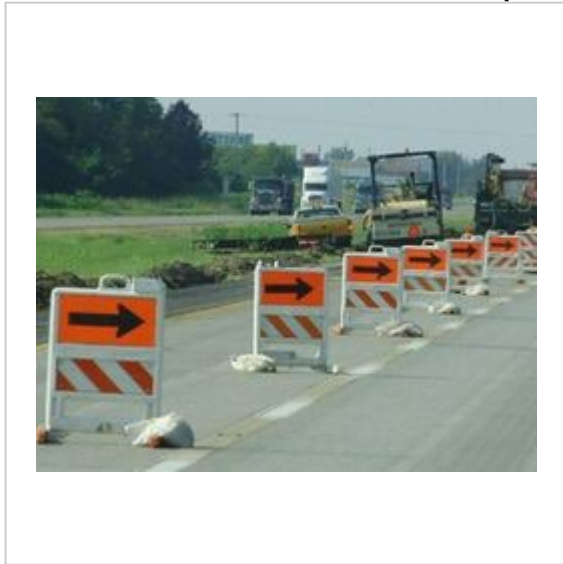
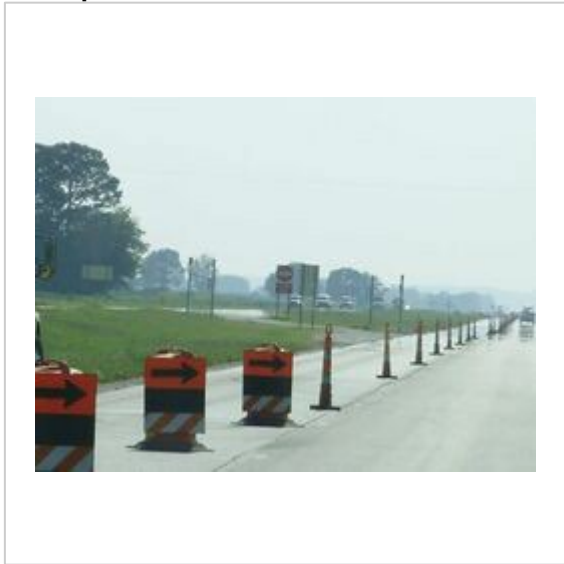
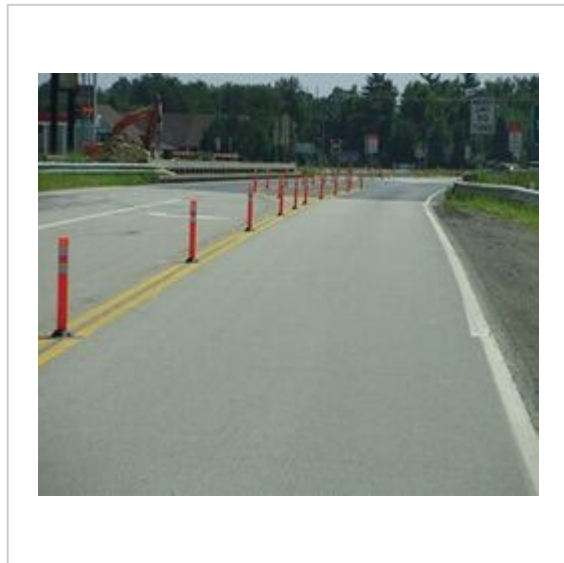
The direction indicator barricades (DIB) in **Picture 5** are commonly used in the merge tapers, but the DIBs in **Picture 6** with the panels on the drum-like channelizer are also acceptable. **Picture 7** shows DIBs during a nighttime work zone.

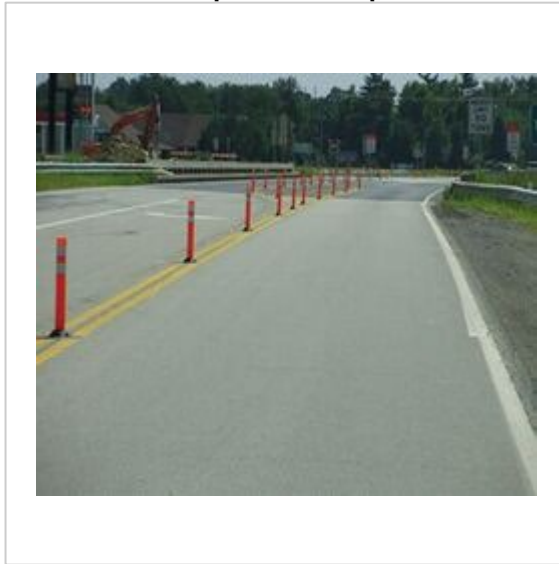
(8)

Picture 8 shows tubular markers separating opposing traffic.

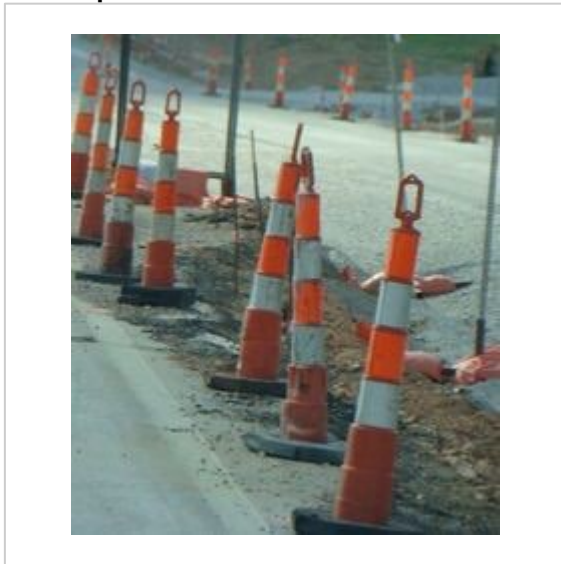
(10)

Picture 9 shows 12-inch cones being used for daytime projects on a minor roadway. **Picture 10** shows trim-line channelizers with poor reflectivity that may have limited nighttime visibility. **Picture 11** shows a damaged trim-line that is in unacceptable condition.

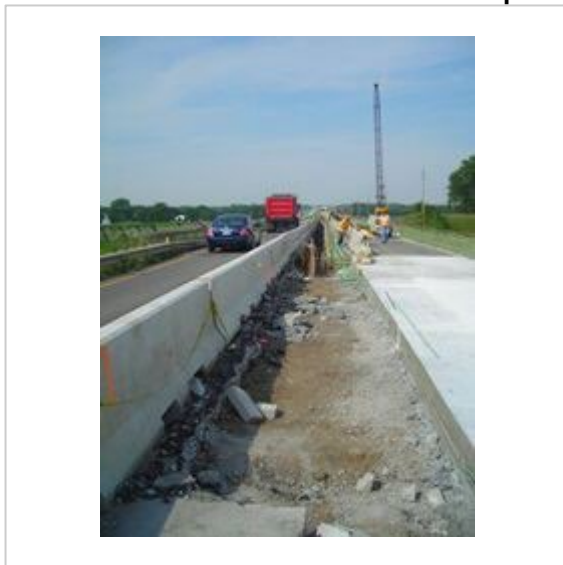
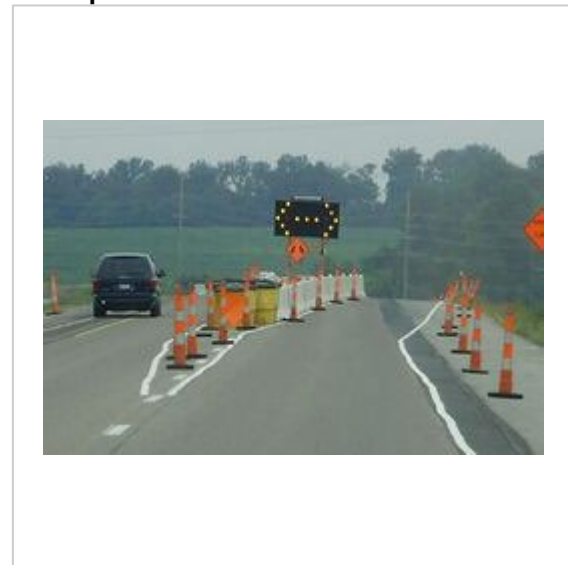
Pictures 1 - 3 are acceptable installations of temporary traffic barriers (TTBs). **Picture 1** shows a TTB shielding motorists from an edge drop-off and the workers from the vehicles. The TTB in **Picture 1** was installed with tie-down straps which prevents tipping of the barrier at a drop-off edge. Stockpiled materials or equipment should not be placed within the 3-foot buffer area behind a tie-down TTB. In **Picture 1**, the work side of the barrier is free of stockpile material or inactive equipment. The clearance (buffer) behind the TTB will change depending on the different types of TTBs and/or anchoring systems being used. The clearance area is needed to not impede the deflection of the TTB should it be struck by an errant vehicle. **Picture 2** shows diverting traffic around a bridge project. **Picture 3** shows a TTB separating head-to-head traffic in an urban setting. For selecting proper TTB types on projects, proper installation of TTB and location of TTB, review [EPG 617 Traffic Barrier, Std. Plans. 617.20 and 619.10](#).

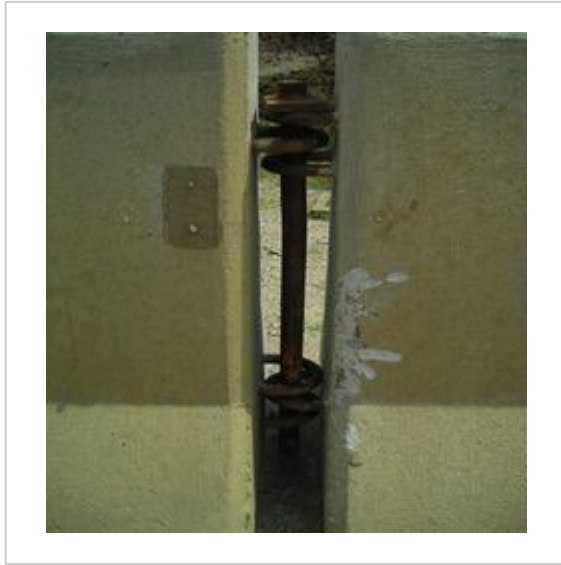
(4)

Pictures 4 and 5 are examples of proper connections of two 3-loop Type F barriers without bottom washer and retainer bolt and nut.

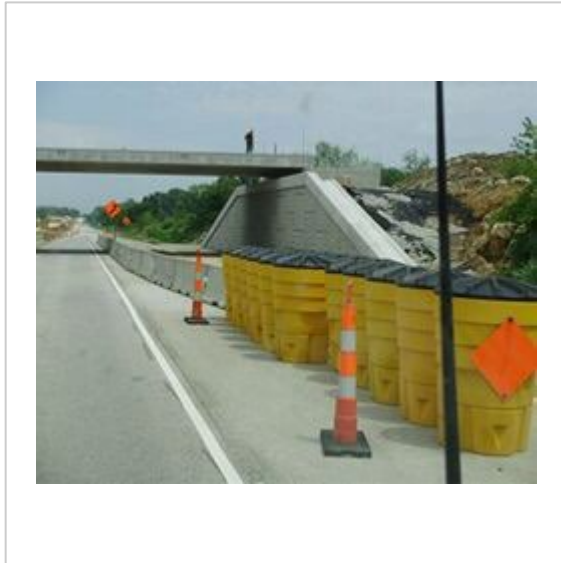
(1)

Picture 1 shows an acceptable installation of a sand filled impact attenuator (SFIA), which can be found in Std. Plan 612.20 and EPG 612 Impact Attenuators. While SFIA is the most common attenuator used, crashworthy end terminals are also available as described in EPG 606.1.3.2 Approved Crashworthy End Terminals. SFIA should be placed a minimum of 24 inches from the end of the blunt end of TTB, guard rail, etc as seen in **Picture 2**.

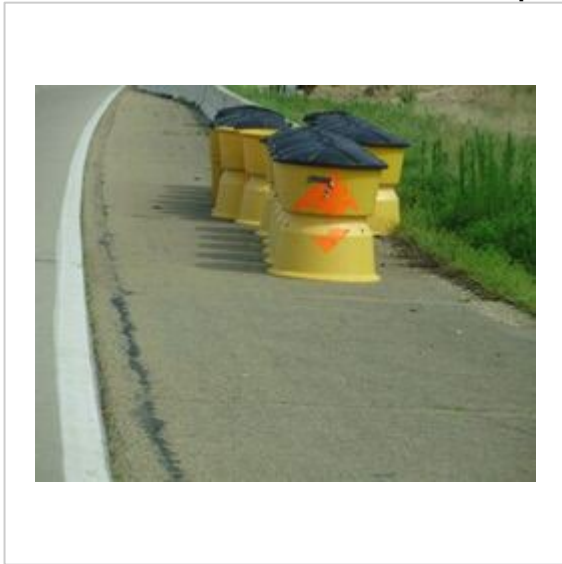
(3)

The Type 1 object marker in **Picture 3** is unacceptable due to the damaged sign sheeting. **Picture 4** shows SFIA barrels/modules in a line from the temporary TTB viewpoint. To be crashworthy, the SFIA barrels/modules must have the proper number and meet spacing requirements. The sand should always be kept dry. If water gets into the barrel it can adversely affect the crashworthiness of the device.

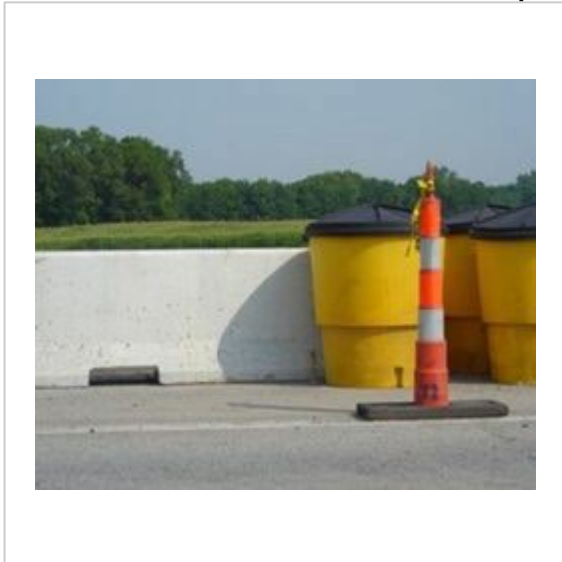
(5)

SFIA barrels/modules in **Picture 5** are unacceptable because they are located too close to the TTB. Parking vehicles or equipment as shown in **Picture 6** is also unacceptable since the vehicles are blocking a crashworthy device. **Picture 7** shows a cluttered SFIA installation with plastic material and barrel channelizers. Note the porta-potty and equipment is in close proximity of the SFIA.

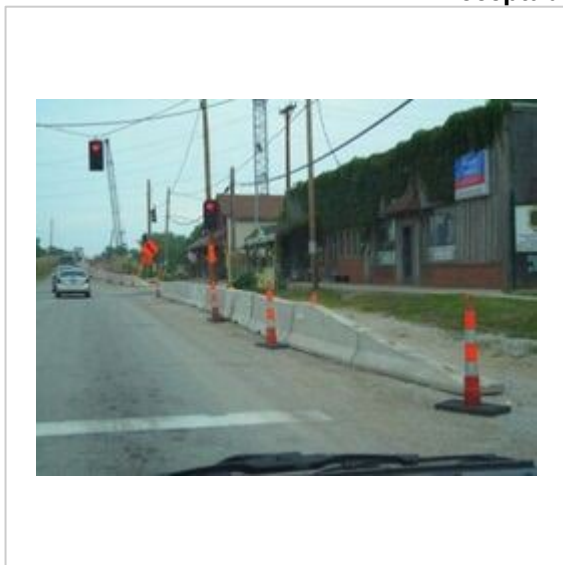
(8)

Picture 8 shows an acceptable installation of a traffic barrier height transition for locations with a posted speed limit of 35 mph or less prior to construction. Proprietary crash cushions as shown in **Pictures 9 and 10** may be used when there is insufficient width to accommodate sand barrels.

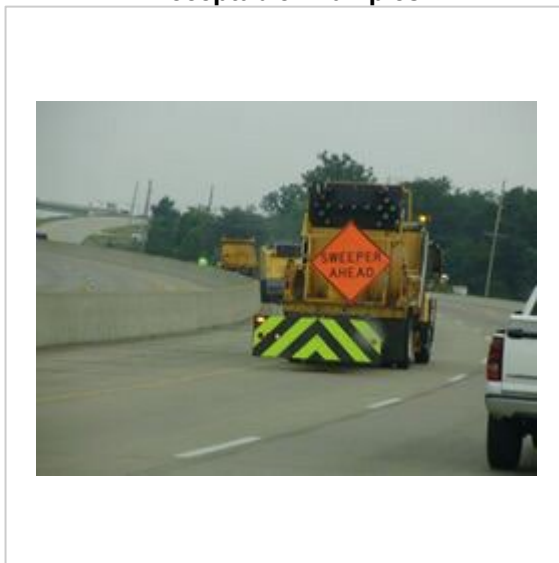
(11)

Picture 11 is the TMA delineation style that is acceptable on projects. Additional information is in [EPG 612 Impact Attenuators](#).

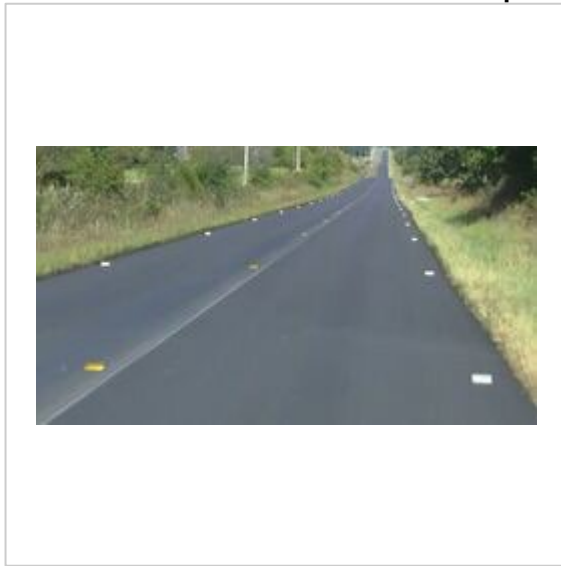
Guidelines for pavement markings are located in EPG 620 Pavement Marking, Missouri Standard Specifications Sec. 620 and Std. Plans. 620.00 and 620.10. **Pictures 1, 2 and 3** are examples of temporary pavement markings (TPM) meeting specifications and standards. **Picture 1** shows TPM for center line and edge lines. **Picture 2** shows a roadway with TPM for a roadway with only a center line stripe during a nighttime review. **Picture 3** shows TPM of a solid line to keep traffic in the designated lanes during a nighttime review.

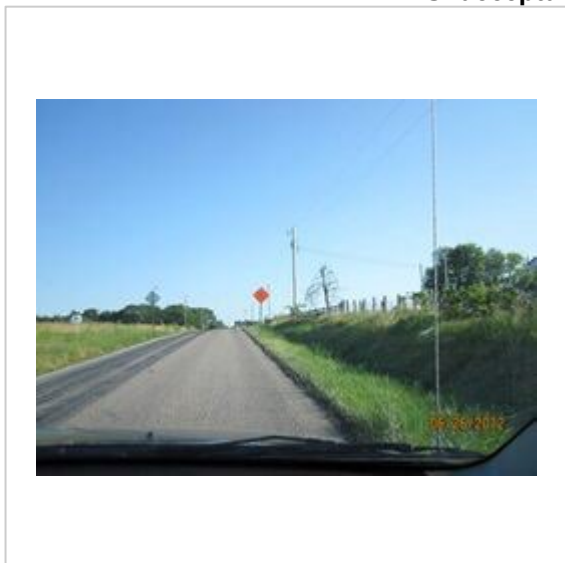
(4)

The roadway in **Picture 4** should have temporary center line pavement markers or stripes. **Picture 5** shows a project using half of the permanent center line stripe as the pavement marking and not place TPM until the other lane is overlaid, which is unacceptable.

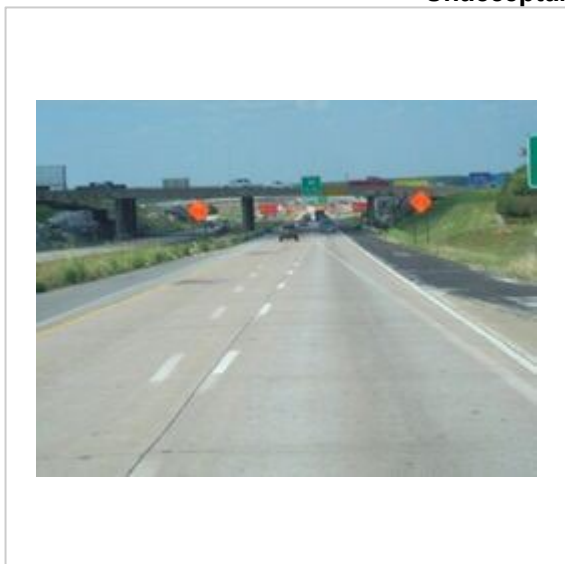
(6)

Pavement marking installation and removal should be done carefully as not to misdirect the road user. The TPM (**Picture 6**) were intended to move the traffic to a temporary shoulder lane.

Note: The permanent center line should have been removed to avoid road user confusion.

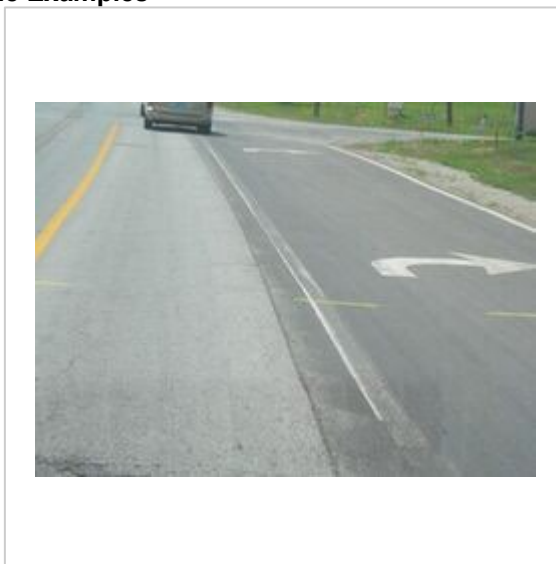
(7)

Picture 7 shows a right turn lane line partially removed, care should be given to completely remove all conflicting markings in accordance with the plans and specifications. In **Picture 8** shows conflicting edge lines across the bridge.

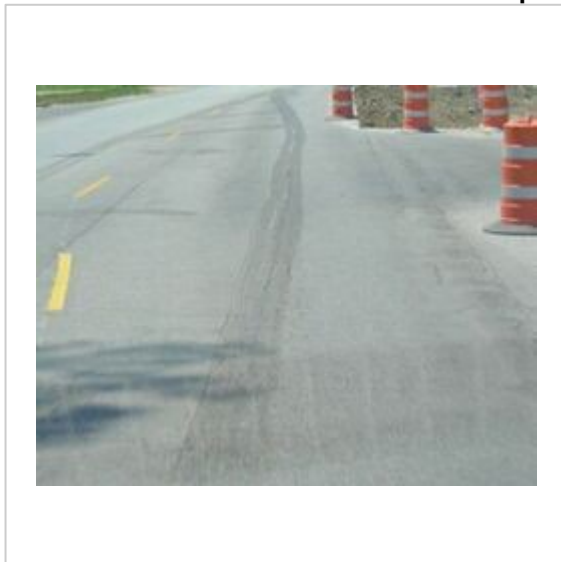
(9)

Pictures 9 - 12 are examples of pavement marking removal. Care should be taken not to scar the pavement when removing markings. **Pictures 11 and 12** shows lane lines leading motorists into the channelization. The dashed line should stop at a point when the two lanes are designated to end.

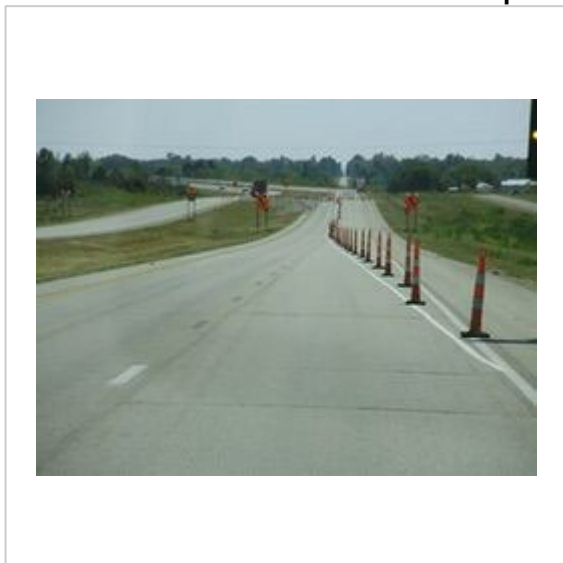
(1)

Pictures 1 - 3 are acceptable examples of traffic management. **Picture 1** shows a long-term stationary work zone that is providing a well-defined merge taper with adequate striping and channelizers. **Picture 2** shows a well-marked crossover. The temporary work zone in **Picture 3** shows proper delineation for head to head traffic while providing access to area businesses.

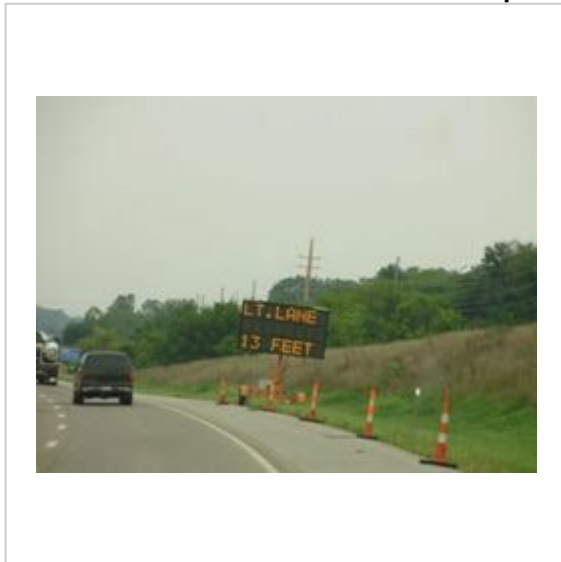
(4)

Pictures 4 and 5 are examples of providing the road user information of how wide the lanes are before entering the workzone. The CMS message provides adequate information to allow the road user to make a decision on the proper lane to use. **Picture 6** is an example of height restriction for the road user.

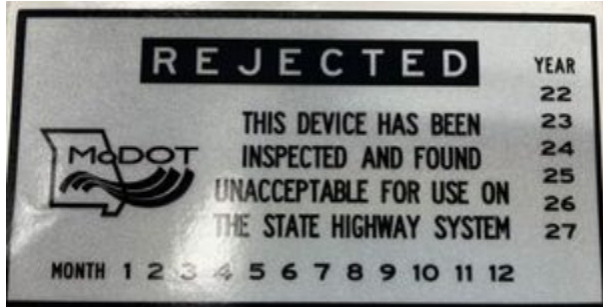
R11-52 REJECTED Decal (Order No. MoDOT 46)

REJECTED stickers, with appropriate month and year designated, may be used by MoDOT personnel to identify unacceptable temporary traffic control devices. For barricades, channelizing devices and signs, the sticker should be located on the front-, left- and lower-most retroreflective area on the device. For other devices, the sticker should be located in a conspicuous place on the device.
